Cover Collapse Sinkhole, Inner Bluegrass Region

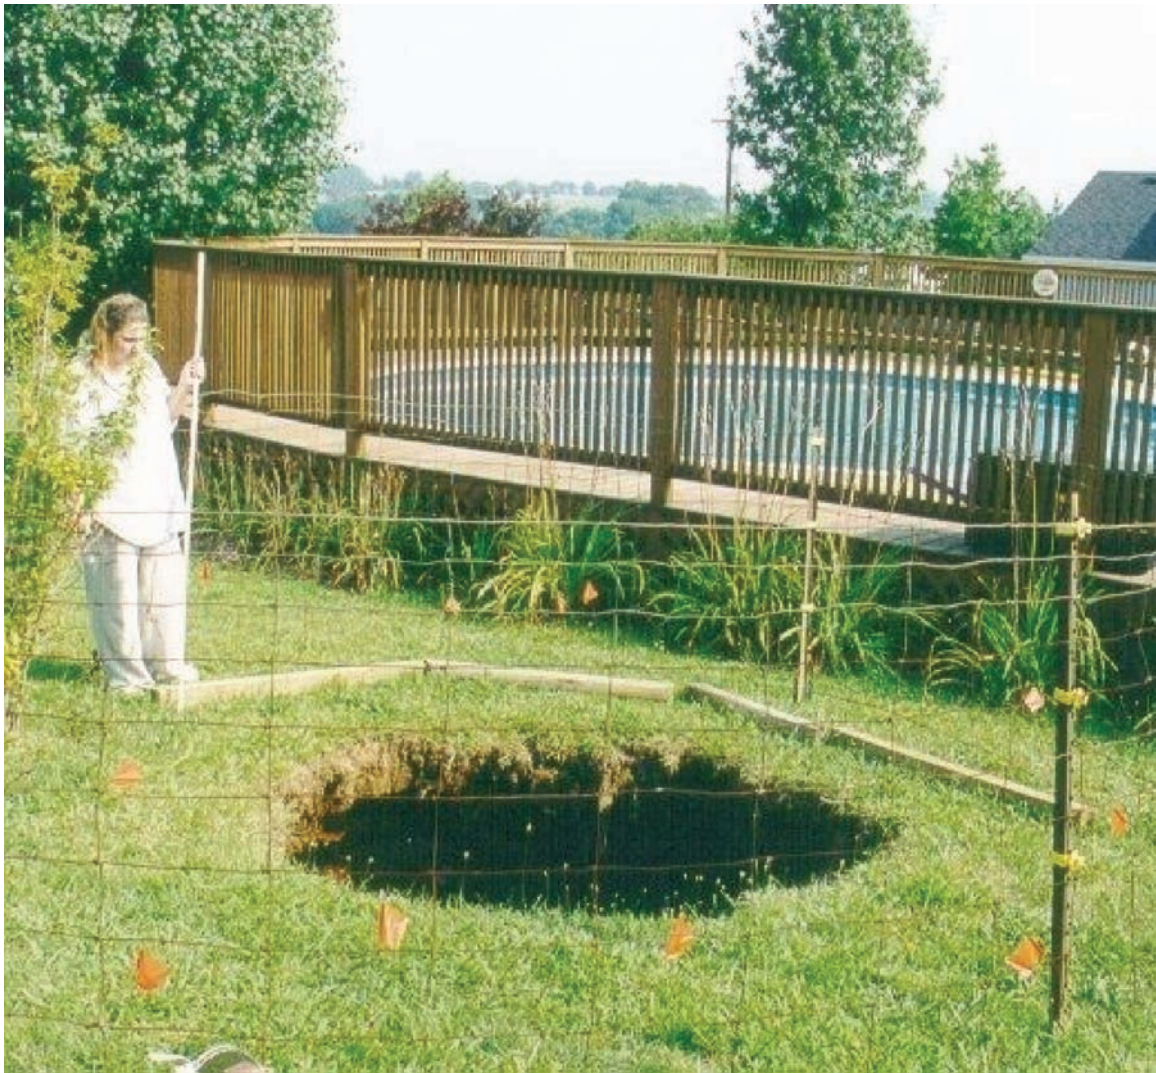
Sinkhole cover collapse in Fayette County. After perhaps years of slow settlement, soils over bedrock solution channels collapse rapidly and wash out, leaving sinkholes such as this. This phenomenon occurs throughout the Inner Bluegrass karst landscape. Photo courtesy of Jim Currens, Kentucky Geological Survey.
