Slope Stability—Bluegrass Hills Region

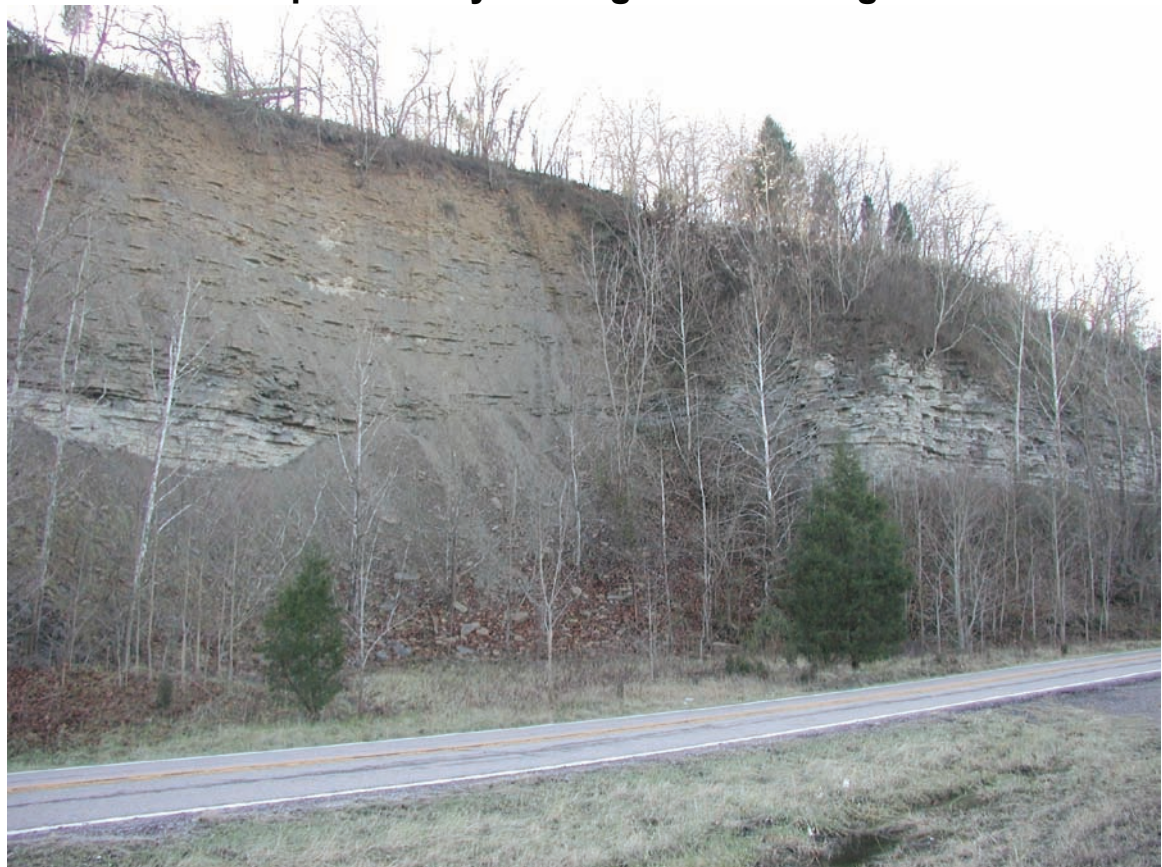
Remnants of a slide seen at the base of this roadcut along Ky. 8 in Bracken County reveal the instability of shales overlying limestone. Slope stability presents problems to development in the Bluegrass Hills Region. Photo by, Dan Carey, Kentucky Geological Survey.
