Construction Hazards

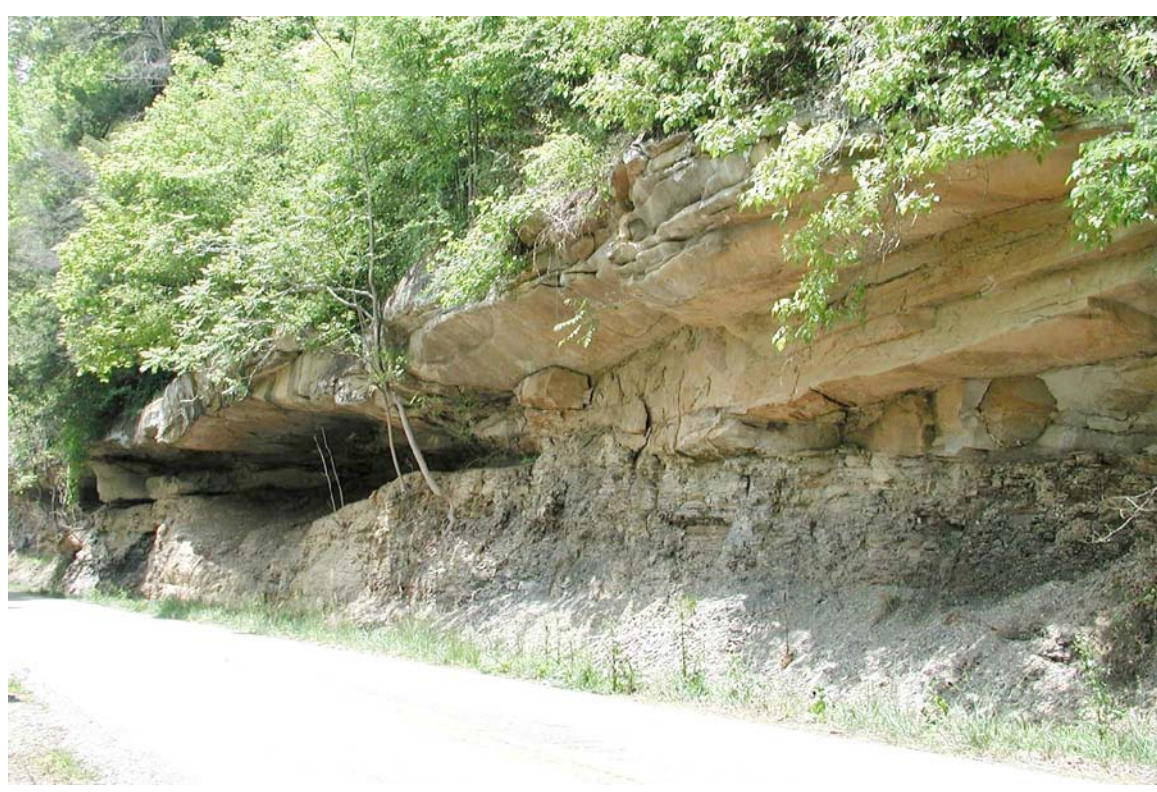
Construction at the interface of sandstone overlying shale in the Pikeville Formation in Clay County (top right) presents possible rockfall problems as the shale erodes beneath. Photo by Dan Carey, Kentucky Geological Survey.

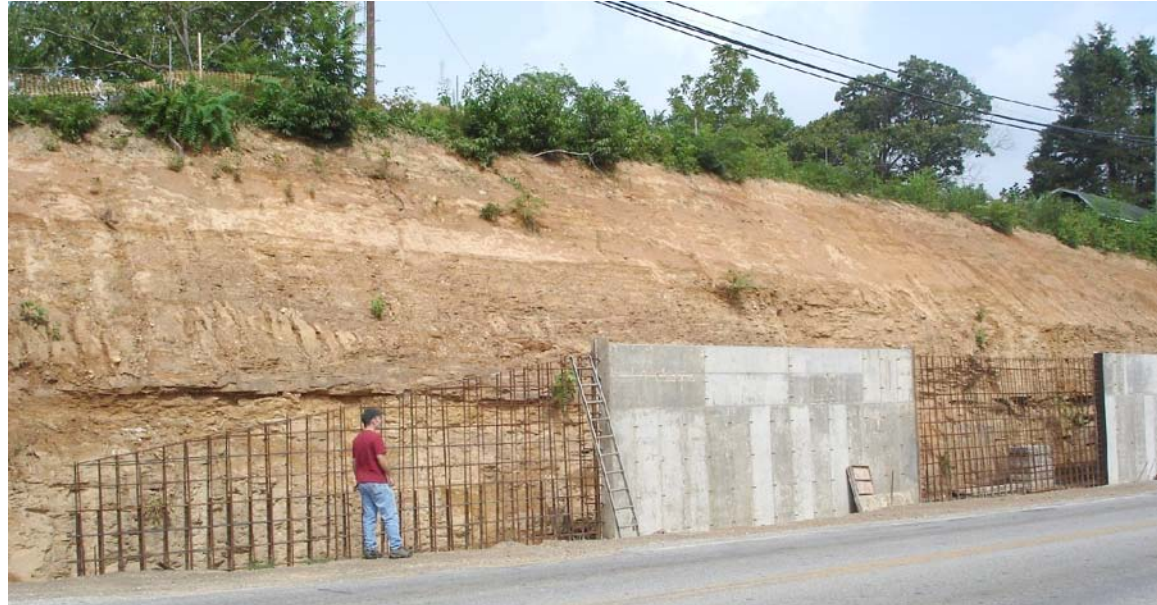
In Whitley County (bottom right), a reinforced concrete wall will keep loose rocks from the Pikeville Formation from falling on the highway along Ky. 26. Photo by Bethany Overfield, Kentucky Geological Survey.
