Landslides and Slope Stability

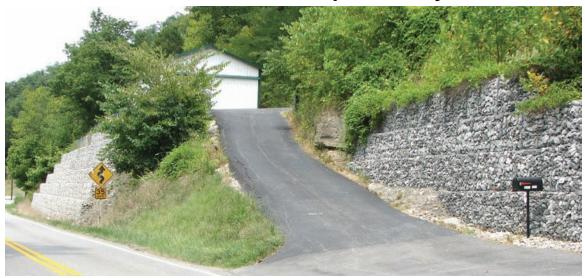
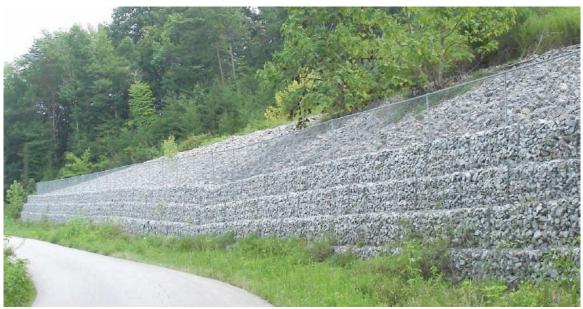
Shales in the Pikeville Formation provide a poor foundation and are unstable on slopes. Hillside construction of roads and homes on shale in Johnson County often requires additional support and drainage management to ensure slope stability. In Whitley County, rock gabions and a chain link fence provide stability to a cut slope in the Pikeville Formation along Doc Siler Road. Photos by Bethany Overfield and Dan Carey, Kentucky Geological Survey.
