# Mine Subsidence

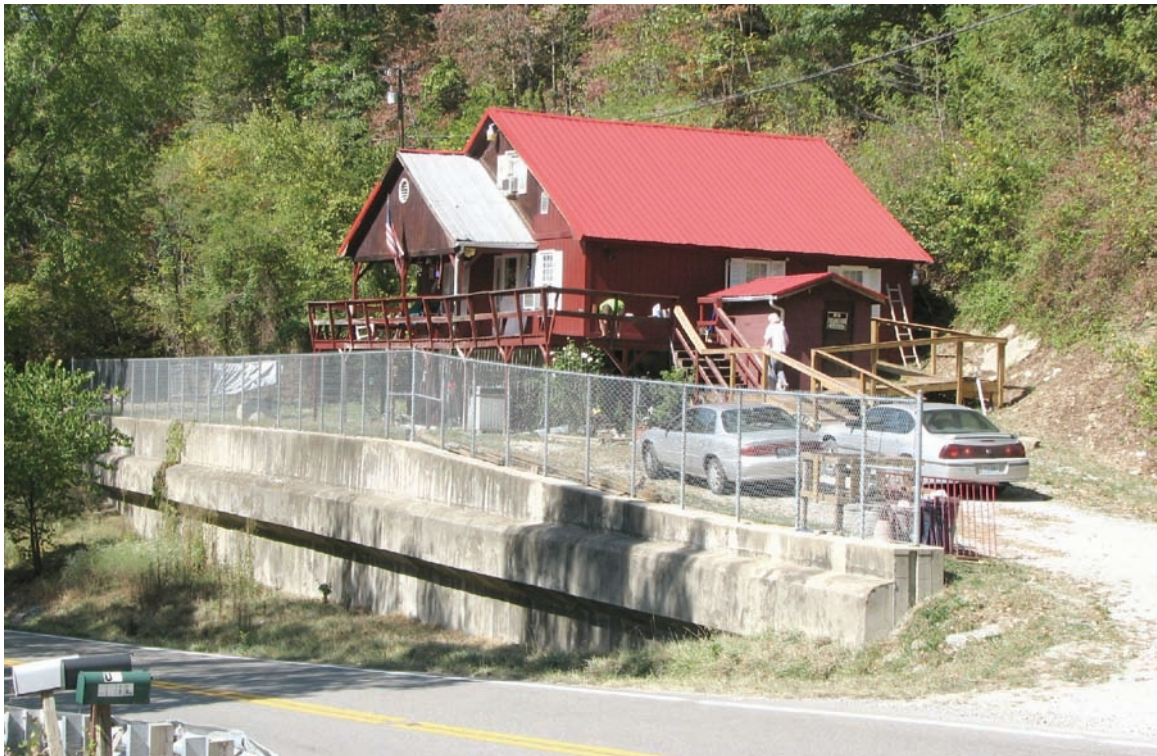
**Mine subsidence can be a problem in some areas. A retaining wall was constructed to stabilize the foundation of this home above an abandoned subsiding underground mine in Letcher County. Photo by Dan Carey, Kentucky Geological Survey.**
