# Geologic Hazards in Kentucky

Daniel I. Carey, Terry D. Hounshell, and John D. Kiefer

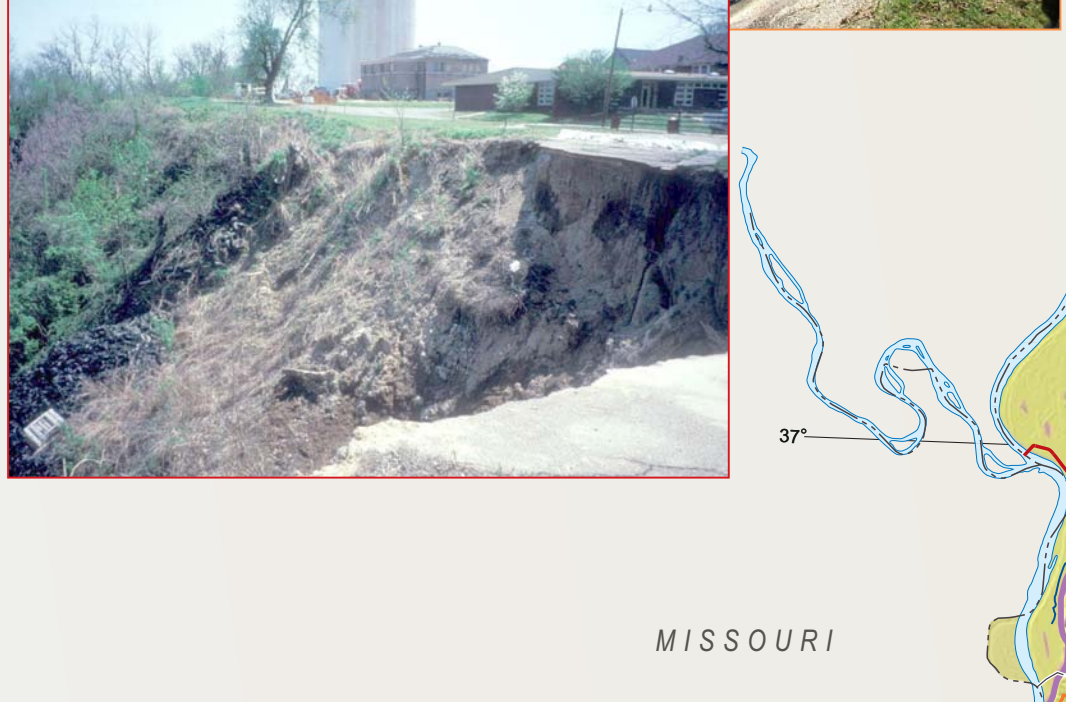
Bluffs of the Mississippi and Ohio Rivers can be unstable, and careful geotechnical site evaluations before construction can save dollars and peace of mind. A slide site in Hickman County (below) was rebuilt (right) by the U.S. Army Corps of Engineers at a cost of millions of dollars. Photo by Mike Lynch, Kentucky Geological Survey.

A large landslide in Hickman in western Kentucky destroyed many houses, and more than \$10 million has been spent to try to fix it. About \$1 million has been spent to repair damage caused by landslides on the Audubon Parkway between Owensboro and Henderson.

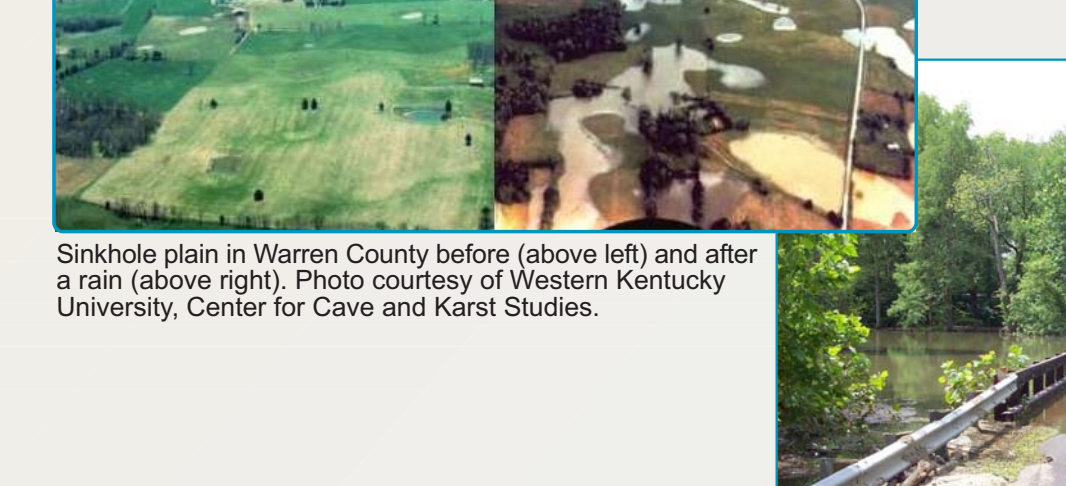
Sinkhole plain in Warren County before (above left) and after a rain (above right). Photo courtesy of Western Kentucky University, Center for Cave and Karst Studies.

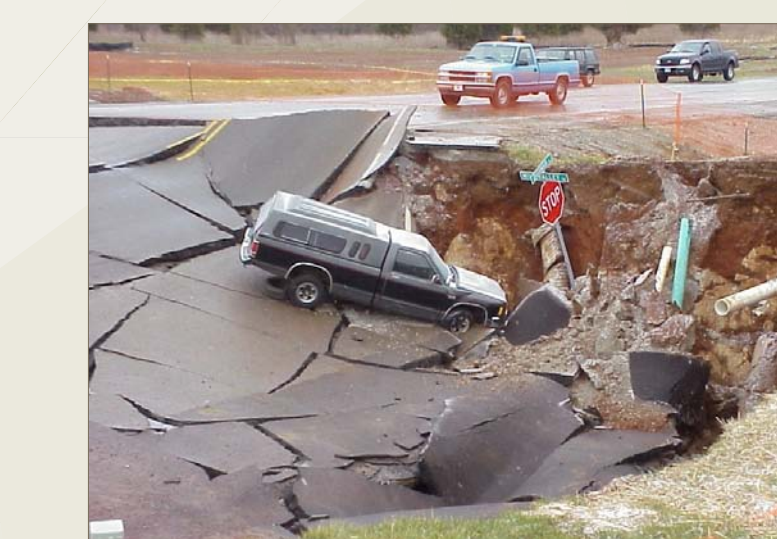
A rather extreme example of karst collapse occurred beneath a Warren County highway. When buildings or roads are constructed in areas of known subsurface cavities, great care must be taken in managing the surface drainage. Photo courtesy of Richard McGeehe, Inspector, Field Operation Branch, Kentucky Division of Water.

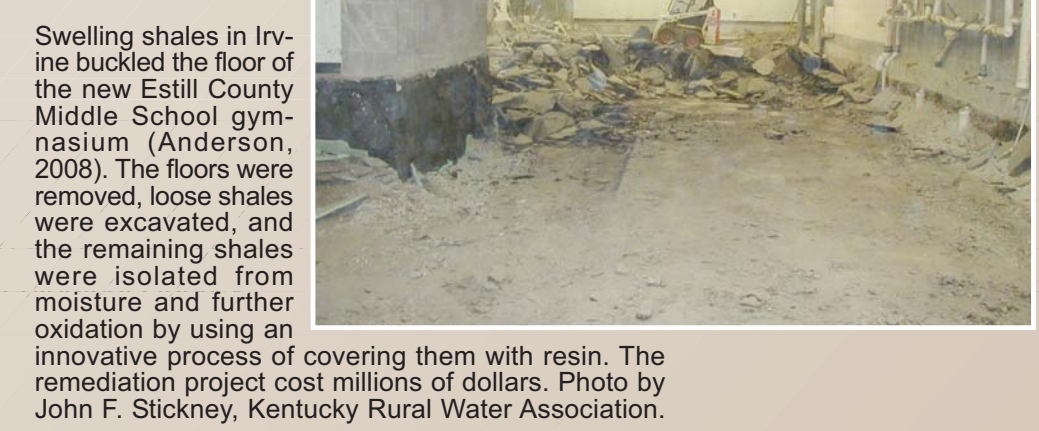
Swelling shales in brick foundations are often buckled by the fine-grained silty clay of the new Estill County Middle School gymnasium (Anderson, 2008). The floors were removed, loose shales were excavated, and the remaining shales were isolated from moisture and further oxidation by using an innovative process of covering them with resin. The remediation project cost millions of dollars. Photo by John F. Slickner, Kentucky Rural Water Association.

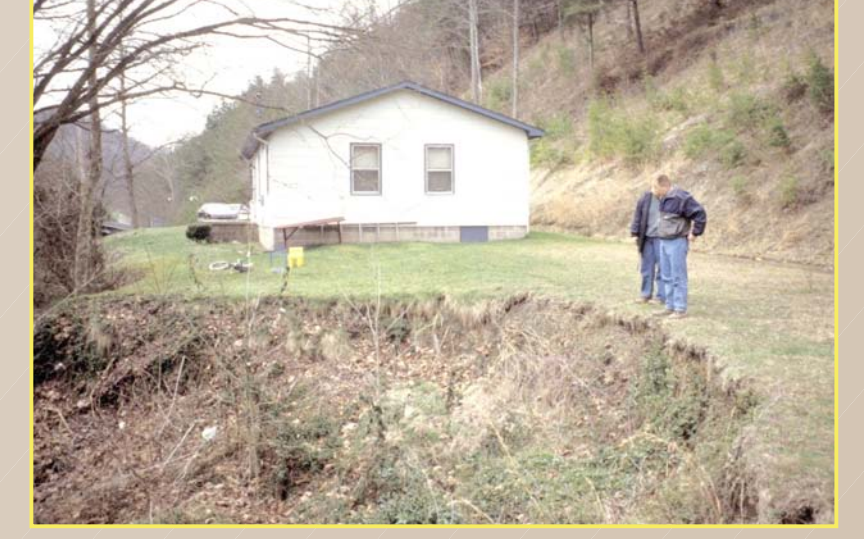
This landslide in Johnson County was caused by a septic drain field. Photo by Paul Howell, U.S. Department of Agriculture, Natural Resources Conservation Service.

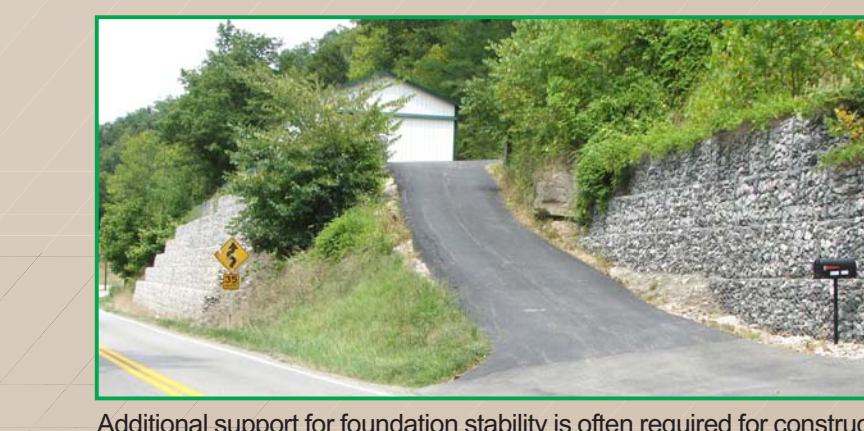
Additional support for foundation stability is often required for construction on slopes (Johnson County). Photo by Dan Carey, Kentucky Geological Survey.
