# Generalized Geologic Map for Land-Use Planning: Lewis County, Kentucky

Daniel I. Carey and Richard E. Sergeant

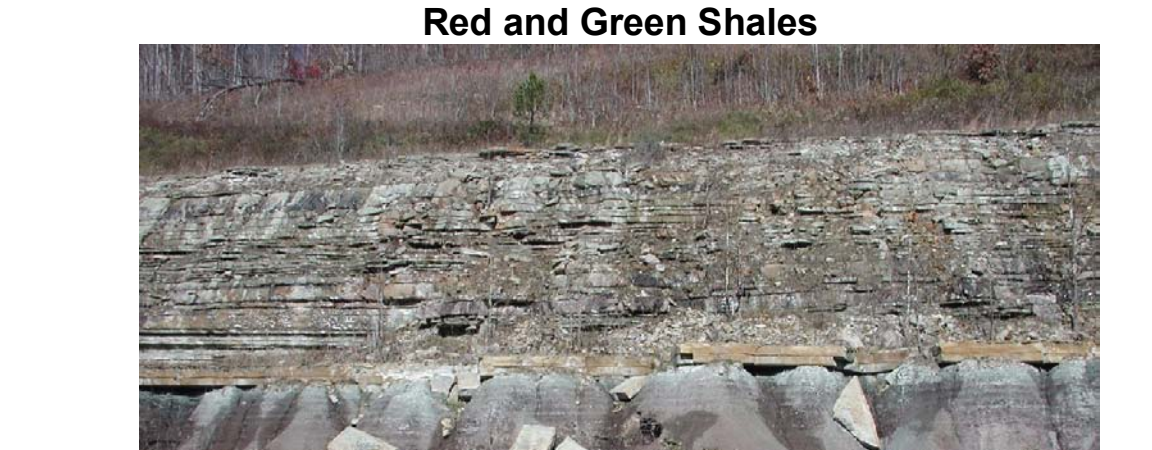
Red and green shales (at the base of the sandstone unit 6) along the AA Highway east of Vanceburg. These shales, similar to unit 5, weather easily and may become plastic when wet. Photo by Dan Carey, Kentucky Geological Survey.
