Landslide, Outwash Deposits, Bluegrass Hills

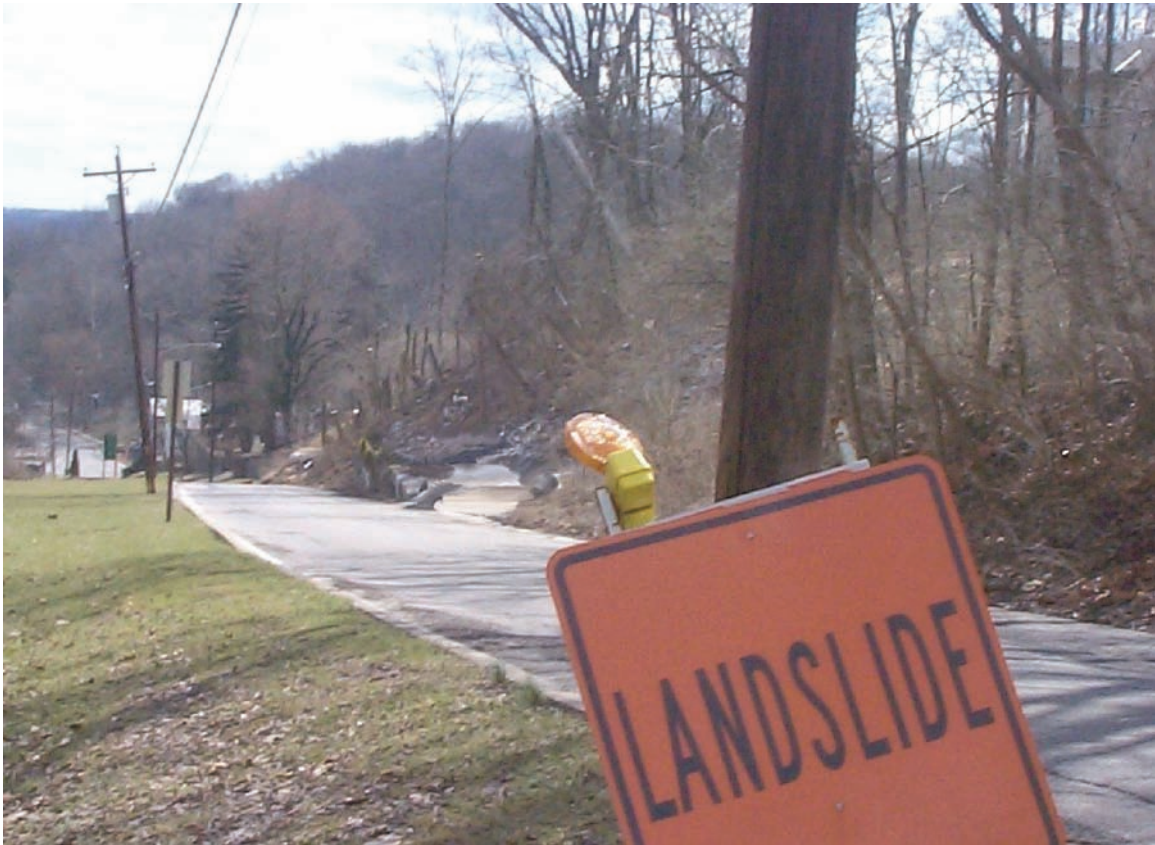
Landslide in the Devou Park area in Kenton County. The toe of the hill was undercut to put in a driveway, and with excess drainage the slope failed. Note the angle of the trees. These sand, silt, clay, and gravel deposits were laid here by glaciers over 125,000 years ago. Photo by Richard Smath, Kentucky Geological Survey.
