**Kentucky Geological Survey**  
William C. Haneberg, State Geologist and Director  
University of Kentucky, Lexington

**Overview of the  
Kentucky Geological Survey  
No. 1 Hanson Aggregates Well,  
Carter County, Kentucky**

**J. Richard Bowersox, Stephen F. Greb, and David C. Harris**

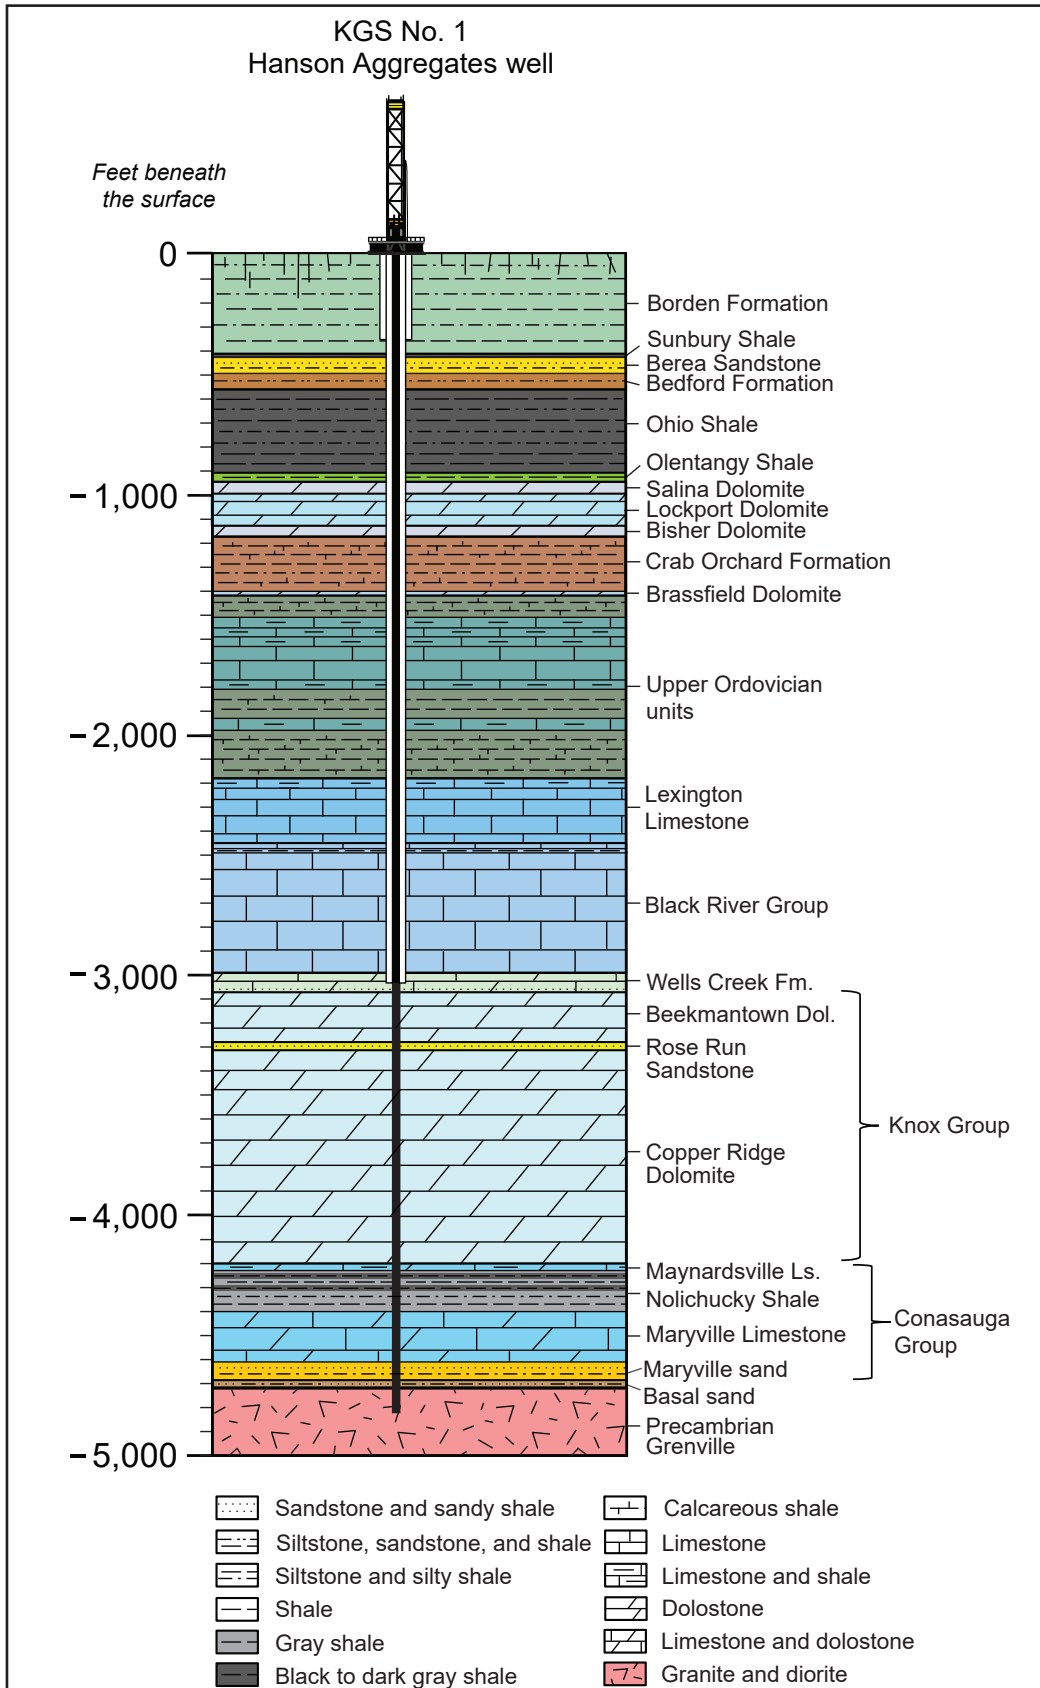
Figure 2. Generalized stratigraphy and lithology of strata penetrated by the No. 1 Hanson Aggregates well.

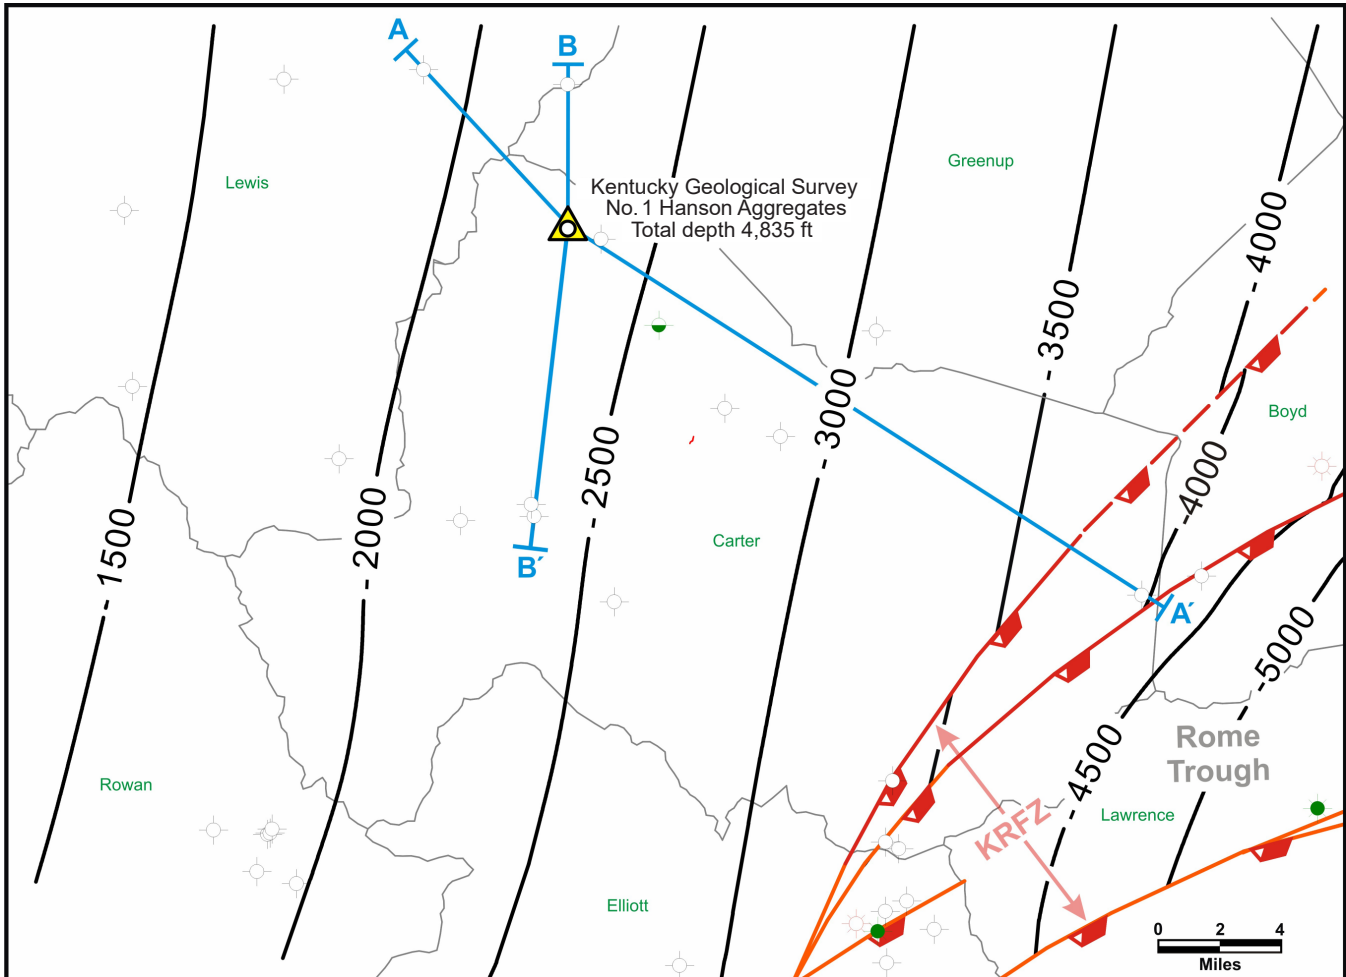
Figure 3. Subsurface structure on top of the Knox Group, in feet below sea level, and index to cross sections A–A' and B–B' (blue). Dip at the top of the Knox north of the Kentucky River Fault Zone is about 1° east-southeast and in the Rome Trough is about 4° southeast and greater.

KGS was entirely in charge of the drilling of the No. 1 Hanson Aggregates well; contractors at the well site reported to KGS during active drilling and testing. Major operational decisions during drilling, coring, logging, and testing were made by KGS. After the permits were approved, the well was drilled without incident in the spring of 2013. Operations on the well site commenced on March 17, 2013, and were completed on schedule on April 10 (Fig. 14). The well's location, approximately midway between two dry exploratory test wells, was selected, in part, to avoid encountering hydrocarbons during drilling and testing (Fig. 3).

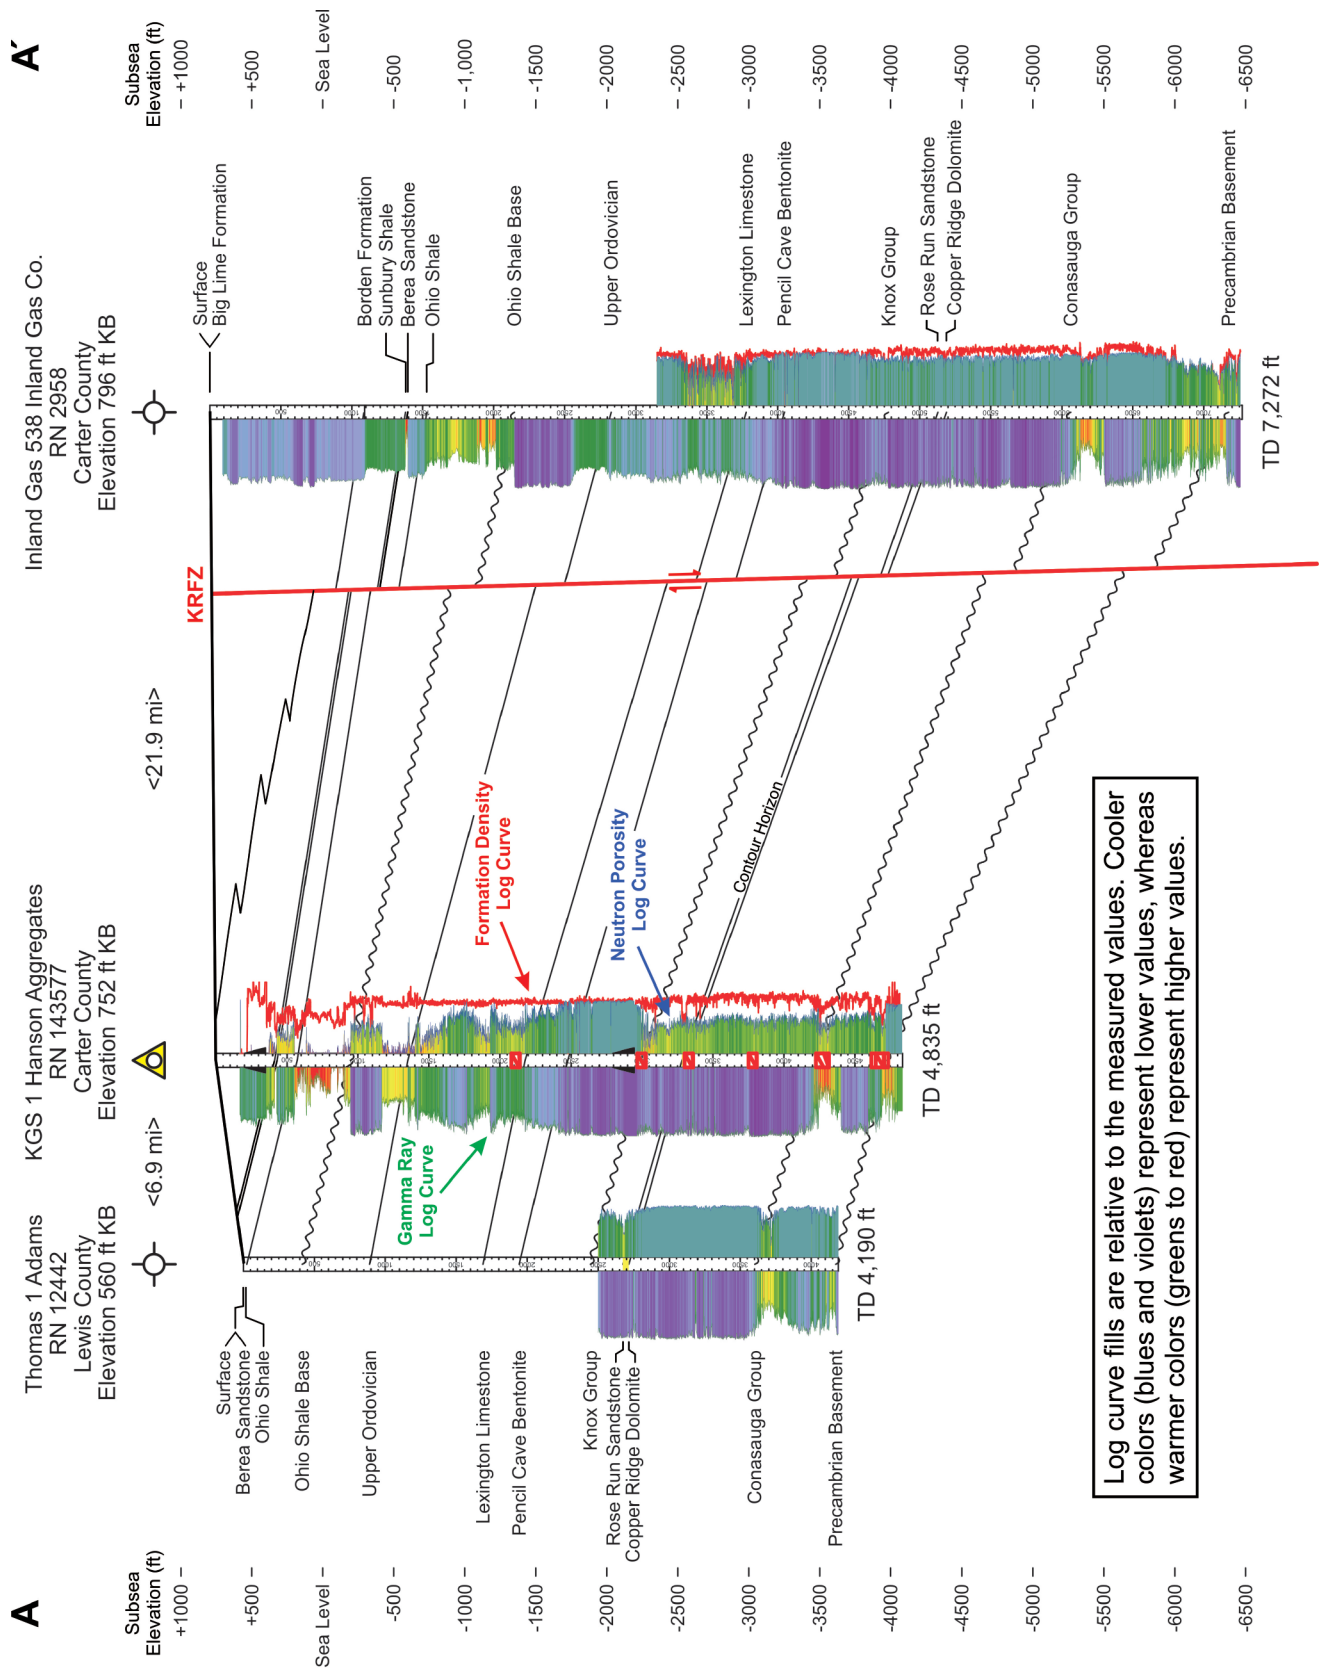
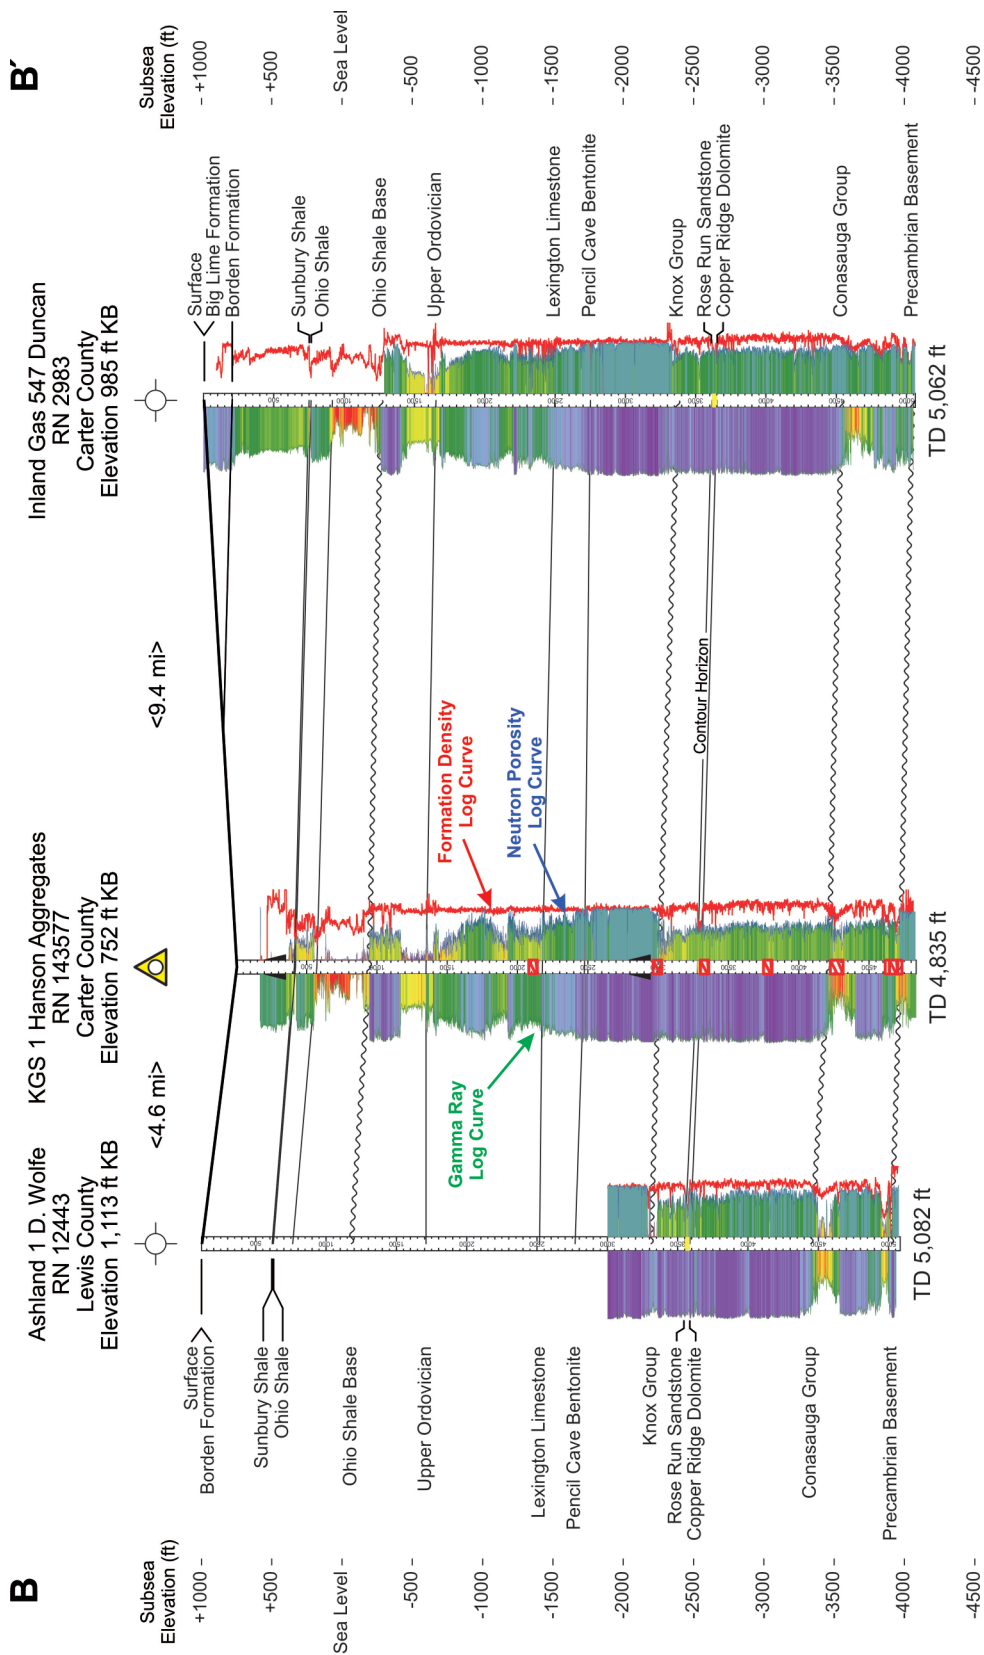
Figure 4. See caption on previous page.

Figure 4. Subsurface structural cross sections through the No. 1 Hanson Aggregates well (Fig. 3). Northwest-southeast cross section A–A' crosses a strand of the Kentucky River Fault Zone with about 250 ft of dip offset.

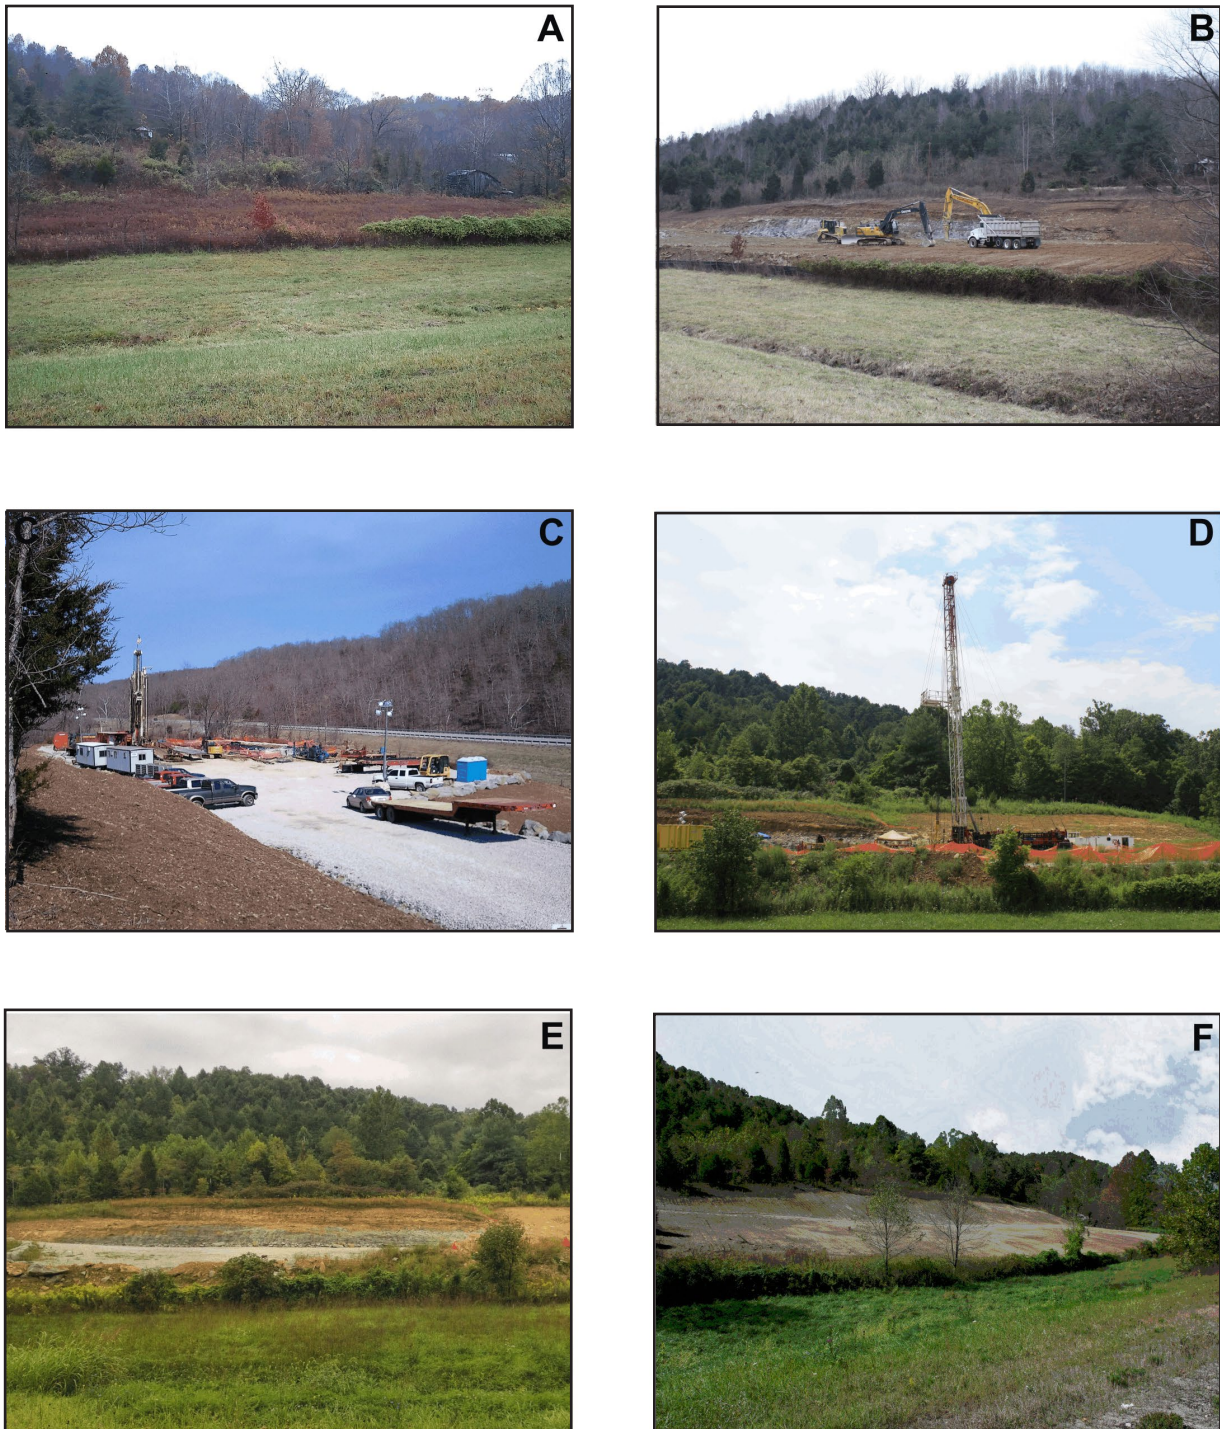
Figure 5. Construction, operations, and remediation of the No. 1 Hanson Aggregates well site. (A) Preconstruction view of the well site on Dec. 12, 2012. The well site is in the overgrown field behind the mowed AA Highway right-of-way. An abandoned tobacco barn is in the background on the right and an abandoned house on the left at the tree line. View is from the AA Highway. (B) Well-site construction on Jan. 14, 2013. The well site covered about 1 acre and was leveled to accommodate the drilling rig. A highwall was cut into the Cowbell Member of the Borden Formation at the back of the site to provide enough room for the drilling rig, water tanks, and trucks delivering equipment and supplies. The highwall was fenced with orange heavyweight plastic fencing for safety. View is from the AA Highway. (C) The drill site during the retrieval of core 8 on April 17, 2013. The access road is in the lower right corner of the photo and the AA Highway is in the background. (D) The service rig on the well site during the step-rate test in the Copper Ridge Dolomite on Aug. 11, 2013. View is from the AA Highway. (E) The well site viewed from the AA Highway on Sept. 18, 2013, before surface remediation. (F) The remediated well site viewed from the AA Highway on Oct. 10, 2013.

posed project (Fig. 5A). No releases or threatened releases of hazardous substances were indicated at the proposed well site. KGS identified domestic water wells within a mile of the proposed well site before drilling commenced in order to address any community concerns about the potential for groundwater contamination. Water wells were located southeast of the well site in residential areas bracketing the AA Highway (Ky. 9). We informed 20 nearby residents about the proposed project and asked for permission to conduct baseline groundwater sampling from their domestic water wells. In the end, two landowners consented to the sampling. At the time wells were sampled, we also sampled Grassy Creek at two locations bracketing the well site in order to have baseline surface-water samples. A public meeting was held in Grayson, Ky., in December 2012 to present background information about subsurface carbon storage and how the project would proceed. The meeting was well publicized in print media, on a local radio station, and on the University of Kentucky website, but it was poorly attended, probably because of heavy rainfall that evening. The information was well received by those in attendance, however.

A 1-acre well site and access road were constructed on the Hanson Aggregates property fronting the AA Highway in January 2013 (Figs. 5B–F). Construction required cutting into the hillslope on its south side, leaving a highwall on the southwest side of the well pad (Figs. 5B, D–F). For safety, a fence and warning signs were placed along the top of the cut to warn any visitors to the well site of the slope cut below. The well pad was covered with gravel to mitigate any erosion or stormwater runoff, and provide a working surface for heavy machinery used during the project (Fig. 5C). We ensured that soil and groundwater were protected from leaking drilling and testing fluids, well cuttings, and any collected stormwater by constructing plastic-lined, fenced mud pits (Figs. 5C, D).

The well was drilled with a hydraulic air-rotary/top-drive drilling rig, rated to drill a vertical borehole to 6,000ft (Fig. 5C). Kelly bushing height above the ground surface of this drilling rig was 6.5ft, and all work in the borehole was conducted in reference to KB. Figure 6 is the as-drilled wellbore diagram. The final well construction ensured subsurface pressure control and isolation of the test interval by cementing 7-in. casing from 2,944ft to the surface, slightly shallower than the design depth of 3,000ft; the cement bond quality was verified by a geophysical cement bond log, followed by approval by the Kentucky Division of Oil and Gas, and installation of blowout prevention equipment. Whole-diameter conventional cores would be collected from zones in the several potential confining intervals and saline reservoirs in order to determine chemistry, mineralogy, and permeability of possible caprocks and reservoirs. Coring was conducted by Cor-Pro, a coring contractor from Houston, Texas. The original coring program called for cutting six cores (five 60-ft cores and one 90-ft core) in the Upper Ordovician shale, Beekmantown Do-

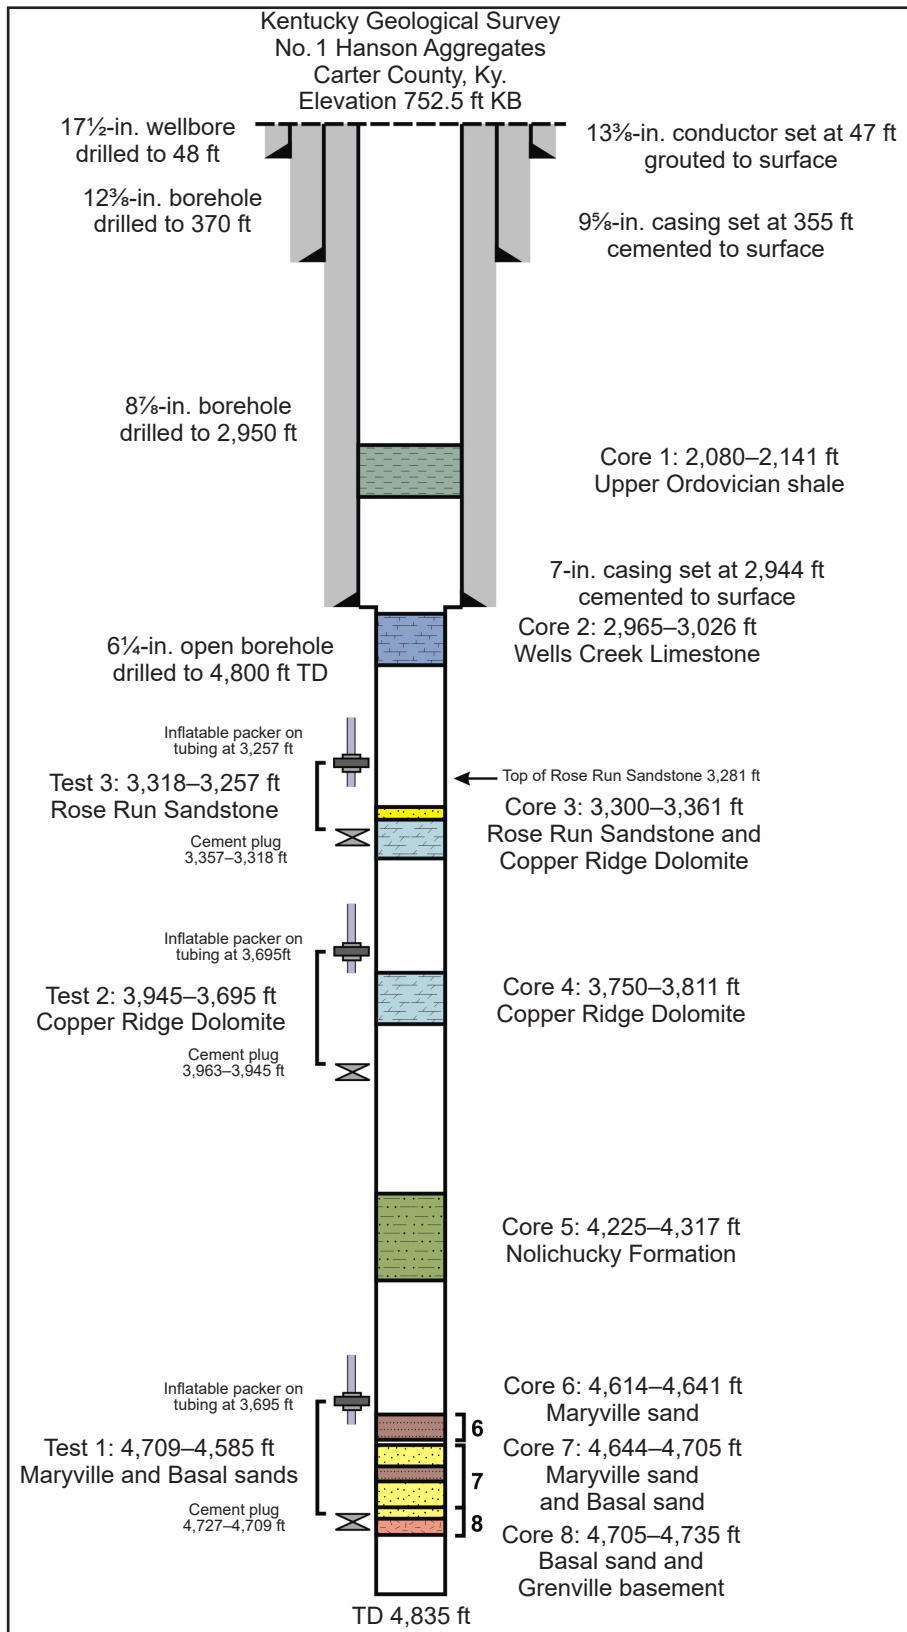
Figure 6. Design of the KGS No. 1 Hanson Aggregates well, showing as-drilled casing depths, cores, and step-rate test intervals. Core 1 was cut using a conventional mud system whereas cores 2 through 8 were cut with fresh water in the wellbore. All testing was conducted in the open, uncased wellbore.

**Test 1: Basal Sand-Maryville Sand.** Test 1 was conducted in the Basal sand-Maryville sand interval from 4,585–4,709 ft (Fig. 6). The interval was prepared by setting a cast-iron bridge plug at 4,727 ft and a cement plug at 4,709–4,727 ft to prevent fluid loss during testing to the underlying fractured Grenville basement rock. The interval was swabbed through tubing prior to the step-rate test in an attempt to recover formation water; however, there was no indication of water influx from the Basal sand-Maryville sand interval after swabbing for several hours. We then terminated water sampling, without recovering a formation-water sample, and the step-rate test proceeded. The surface pumping lines and pressure-control lubricator were pressure-tested to 3,000 psi. The logging string, consisting of a surface readout gage and a memory readout gage, was lowered into the wellbore, and the surface readout gage was positioned at 4,630 ft and the memory readout gage at 4,632 ft. Static bottom-hole pressure was measured, followed by the step-rate test. Stable pumping rates were maintained for 15-min steps, continuing until the test interval fractured; fresh drinking water was used as the test fluid. The pumping rate from 0.25 to 2.0 bbl/min and final pump pressure (in psi) at each step were recorded (Fig. 19A). The Basal sand-Maryville sand interval fractured at a pumping rate of 2.0 bbl/min, a rate of about 2,900 bbl

**Test 3: Rose Run Sandstone.** Test 3 was conducted in the Rose Run Sandstone interval from 3,257–3,318 ft (Fig. 6). The interval was isolated at its base by a cast-iron bridge plug set at 3,337 ft and a cement plug at 3,337–3,318 ft to prevent pressure communication and loss of fluids to underlying strata during testing; the wellbore was plugged and abandoned below 3,318 ft (Fig. 6). The interval was swabbed through tubing in 26 runs prior to the step-rate test to recover formation water, and 53 bbl of water was recovered from the Rose Run. Subsequent analysis of the water sample showed a total dissolved solids residue of 89,773 mg/L. The step-rate test proceeded with pressure testing of the surface pumping lines and pressure-control lubricator to 3,000 psi. The pressure logging string was lowered into the wellbore, and the surface readout gage was positioned at 3,290 ft and the memory readout gage at 3,292 ft. Static bottomhole pressure

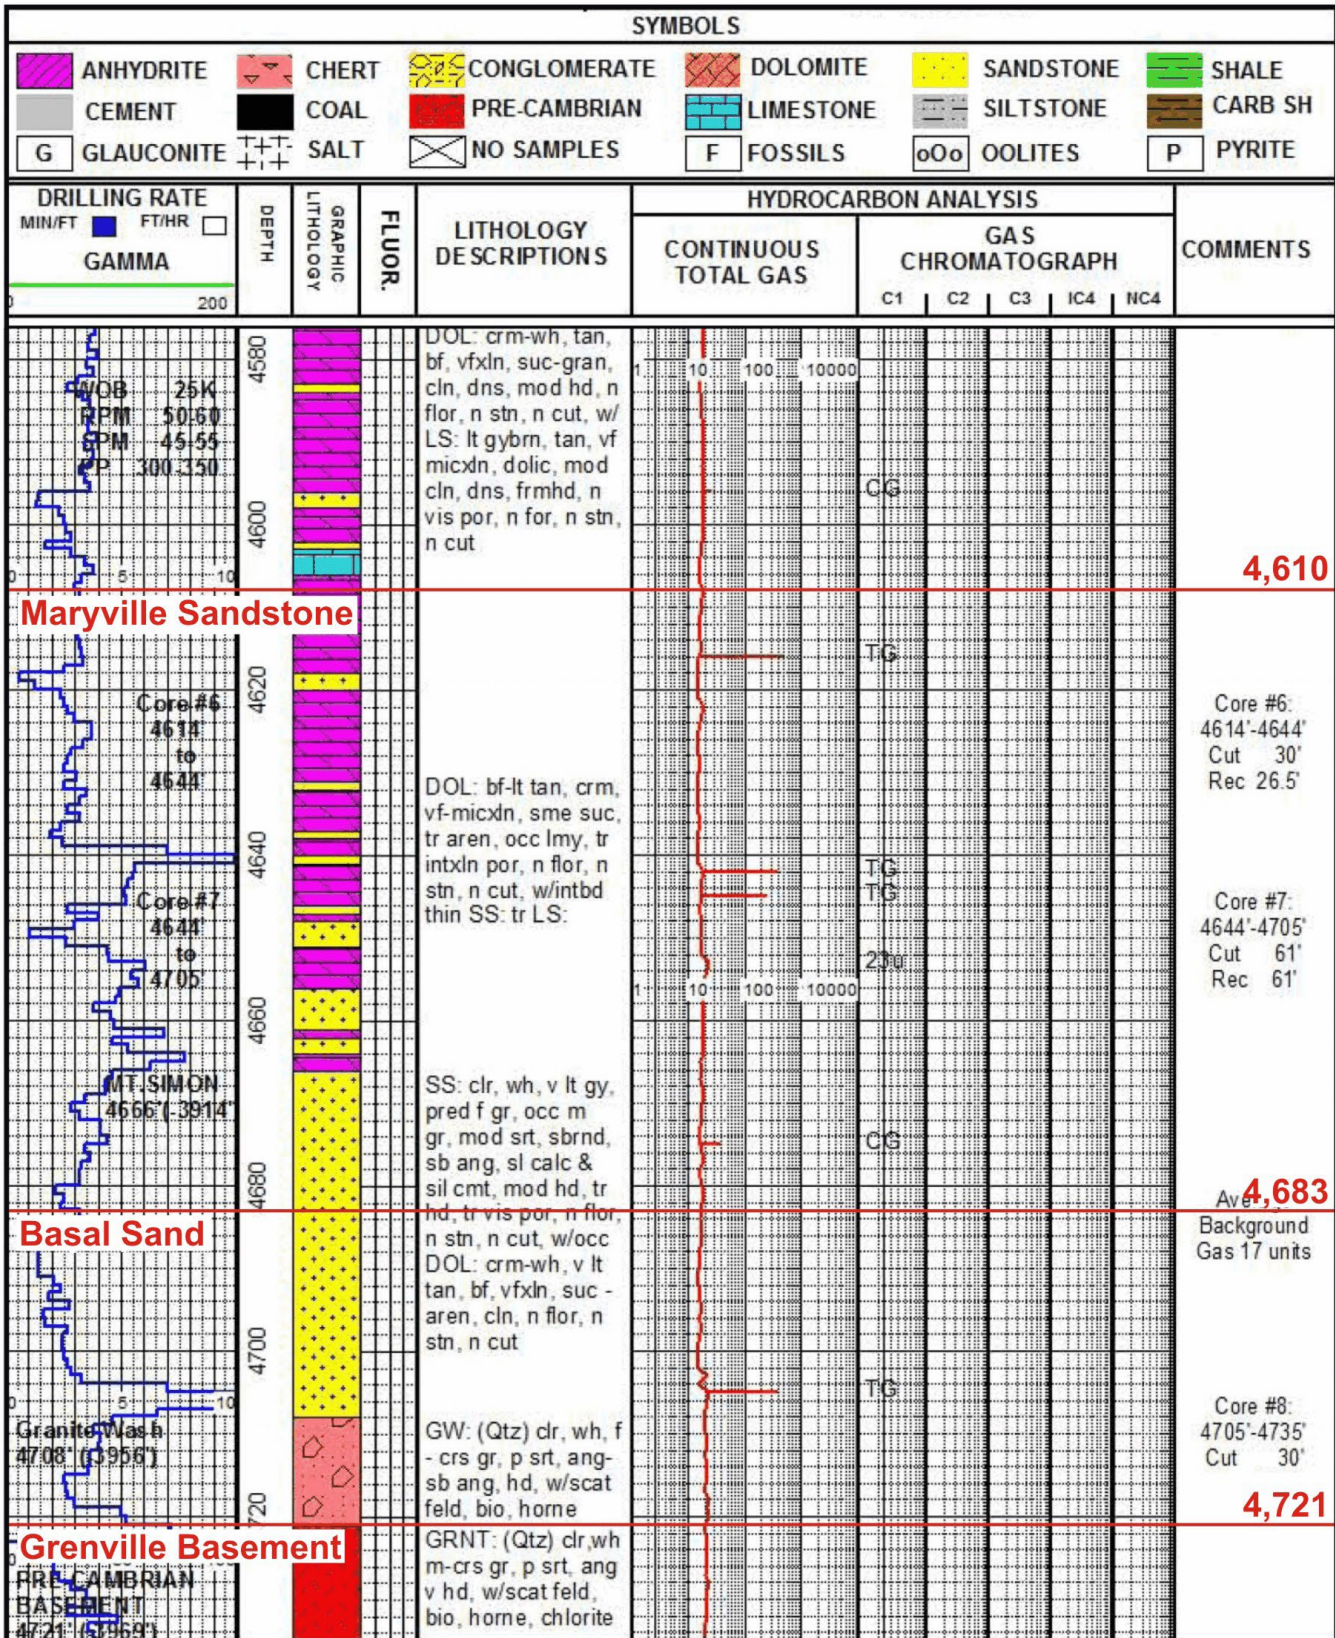
Figure 7. Mud-log section from the No. 1 Hanson Aggregates well, showing the variety of information collected.

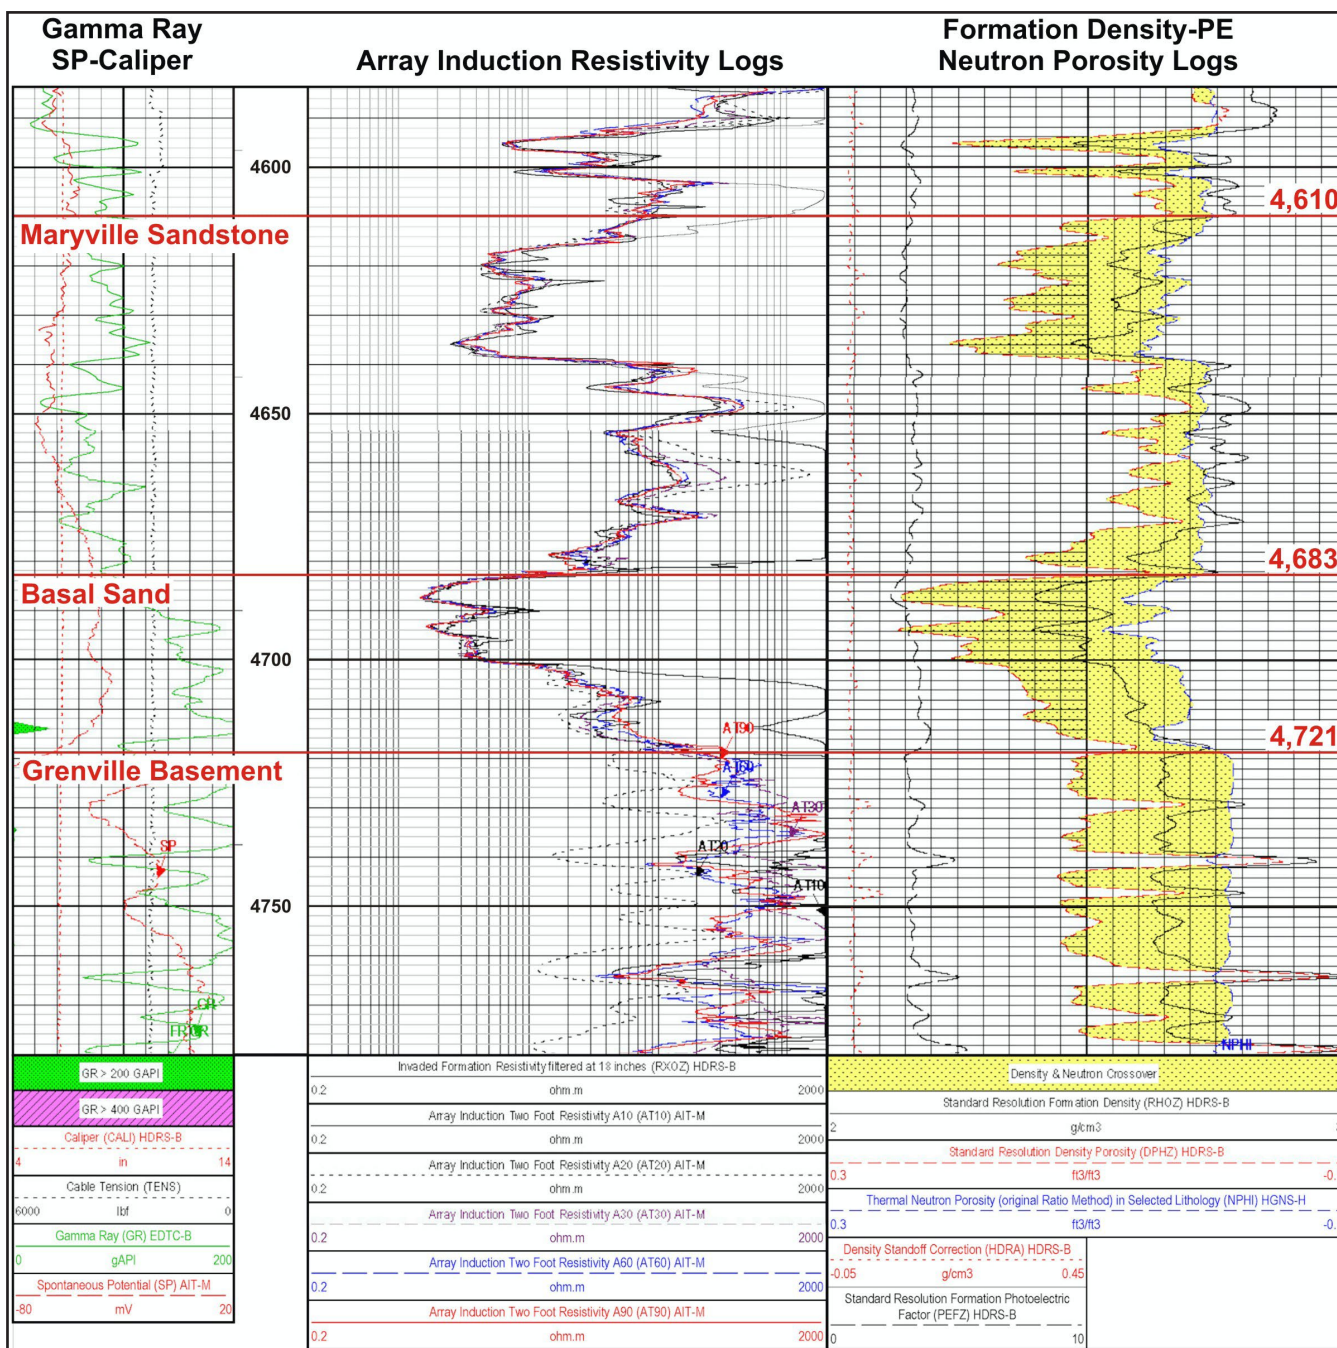
Figure 8. Log section of the gamma-ray/SP, array-resistivity, and formation-density/neutron-porosity logs run in the No. 1 Hanson Aggregates well. Amphibolite bands in the Grenville granite gneiss below 4,721 ft appear as thin, high-density spikes on the formation-density log.

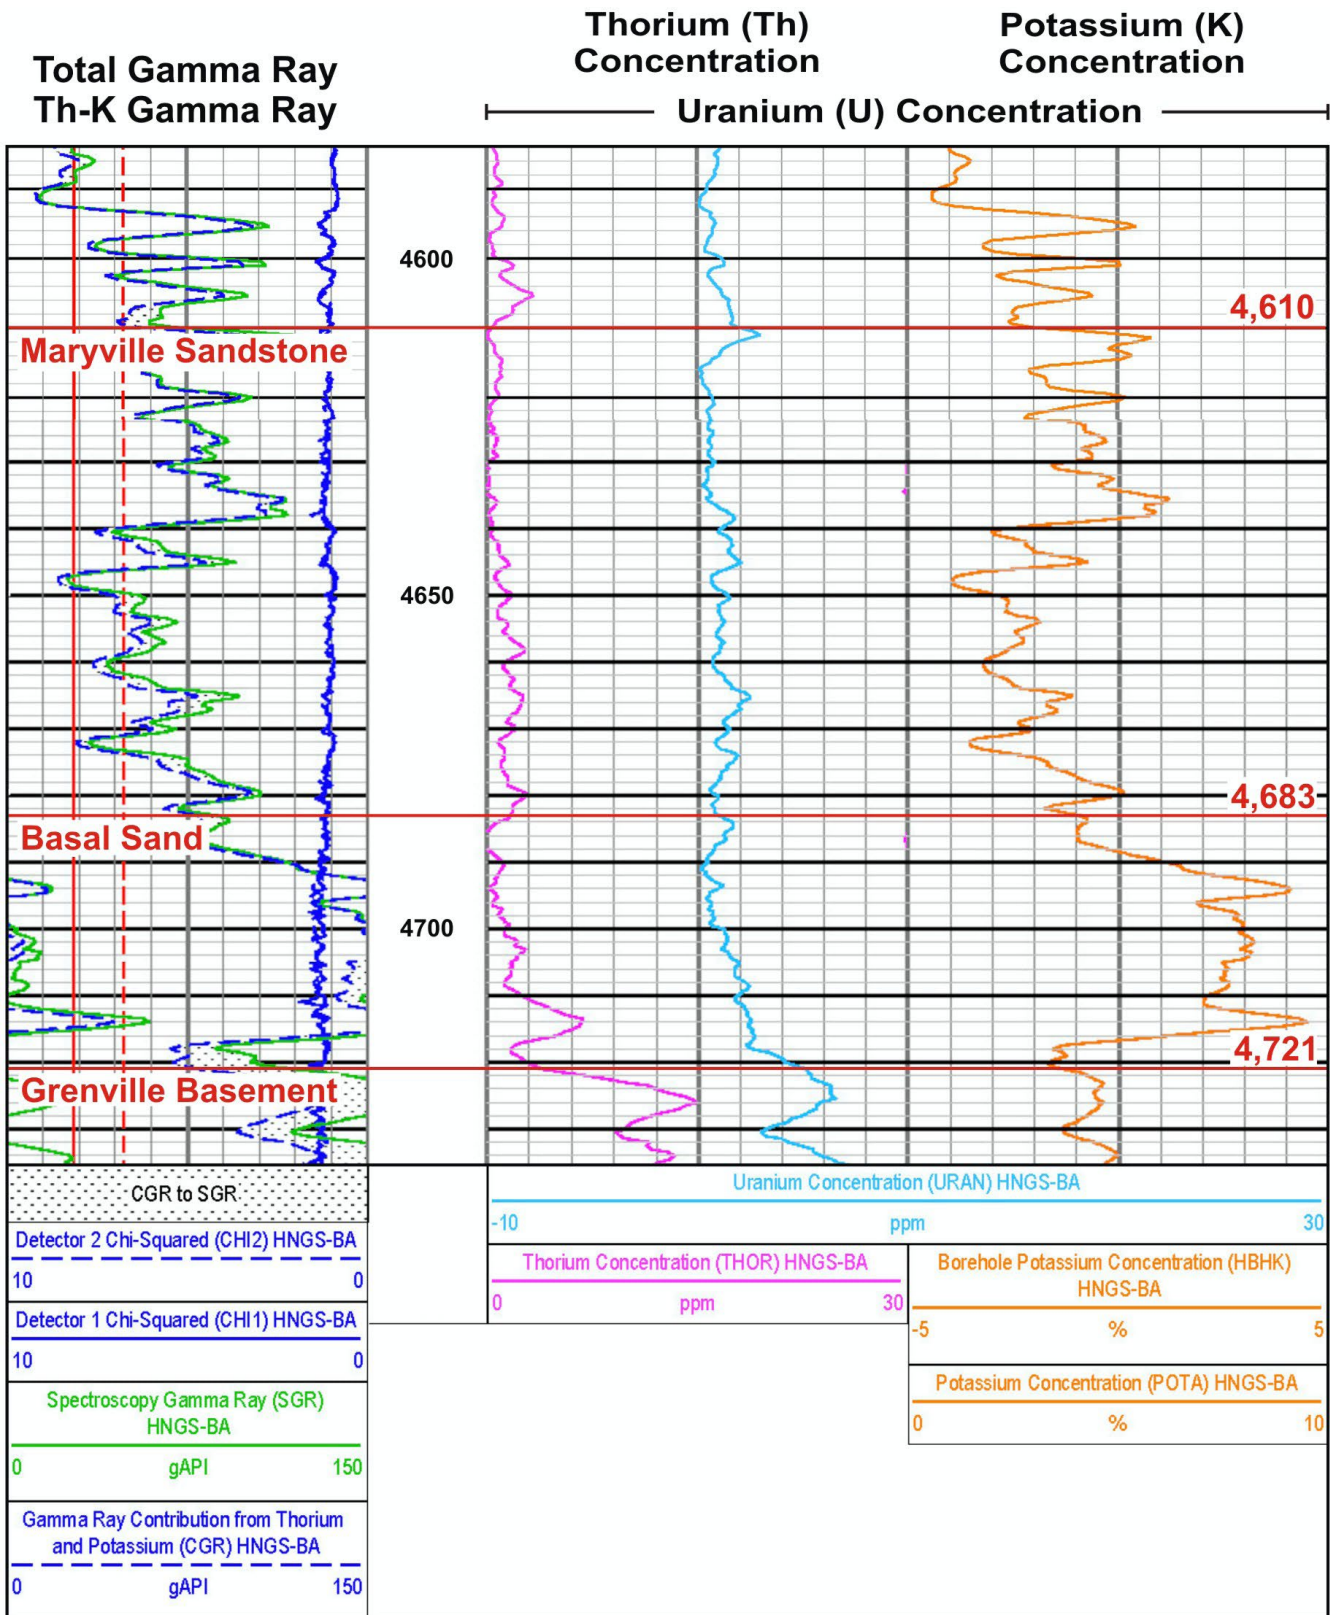
Figure 9. Spectral gamma-ray log section from the No. 1 Hanson Aggregates well. Total gamma-ray log value is most influenced by the uranium-thorium content of the rock; however, the high potassium content in the section from 4,690–4,716ft causes a high gamma-ray value on the log.

The spectral gamma-ray log (Fig. 9) differentiates the gamma-ray contribution of potassium, uranium, and thorium in the total gamma-ray readings. These data can be useful for determin-

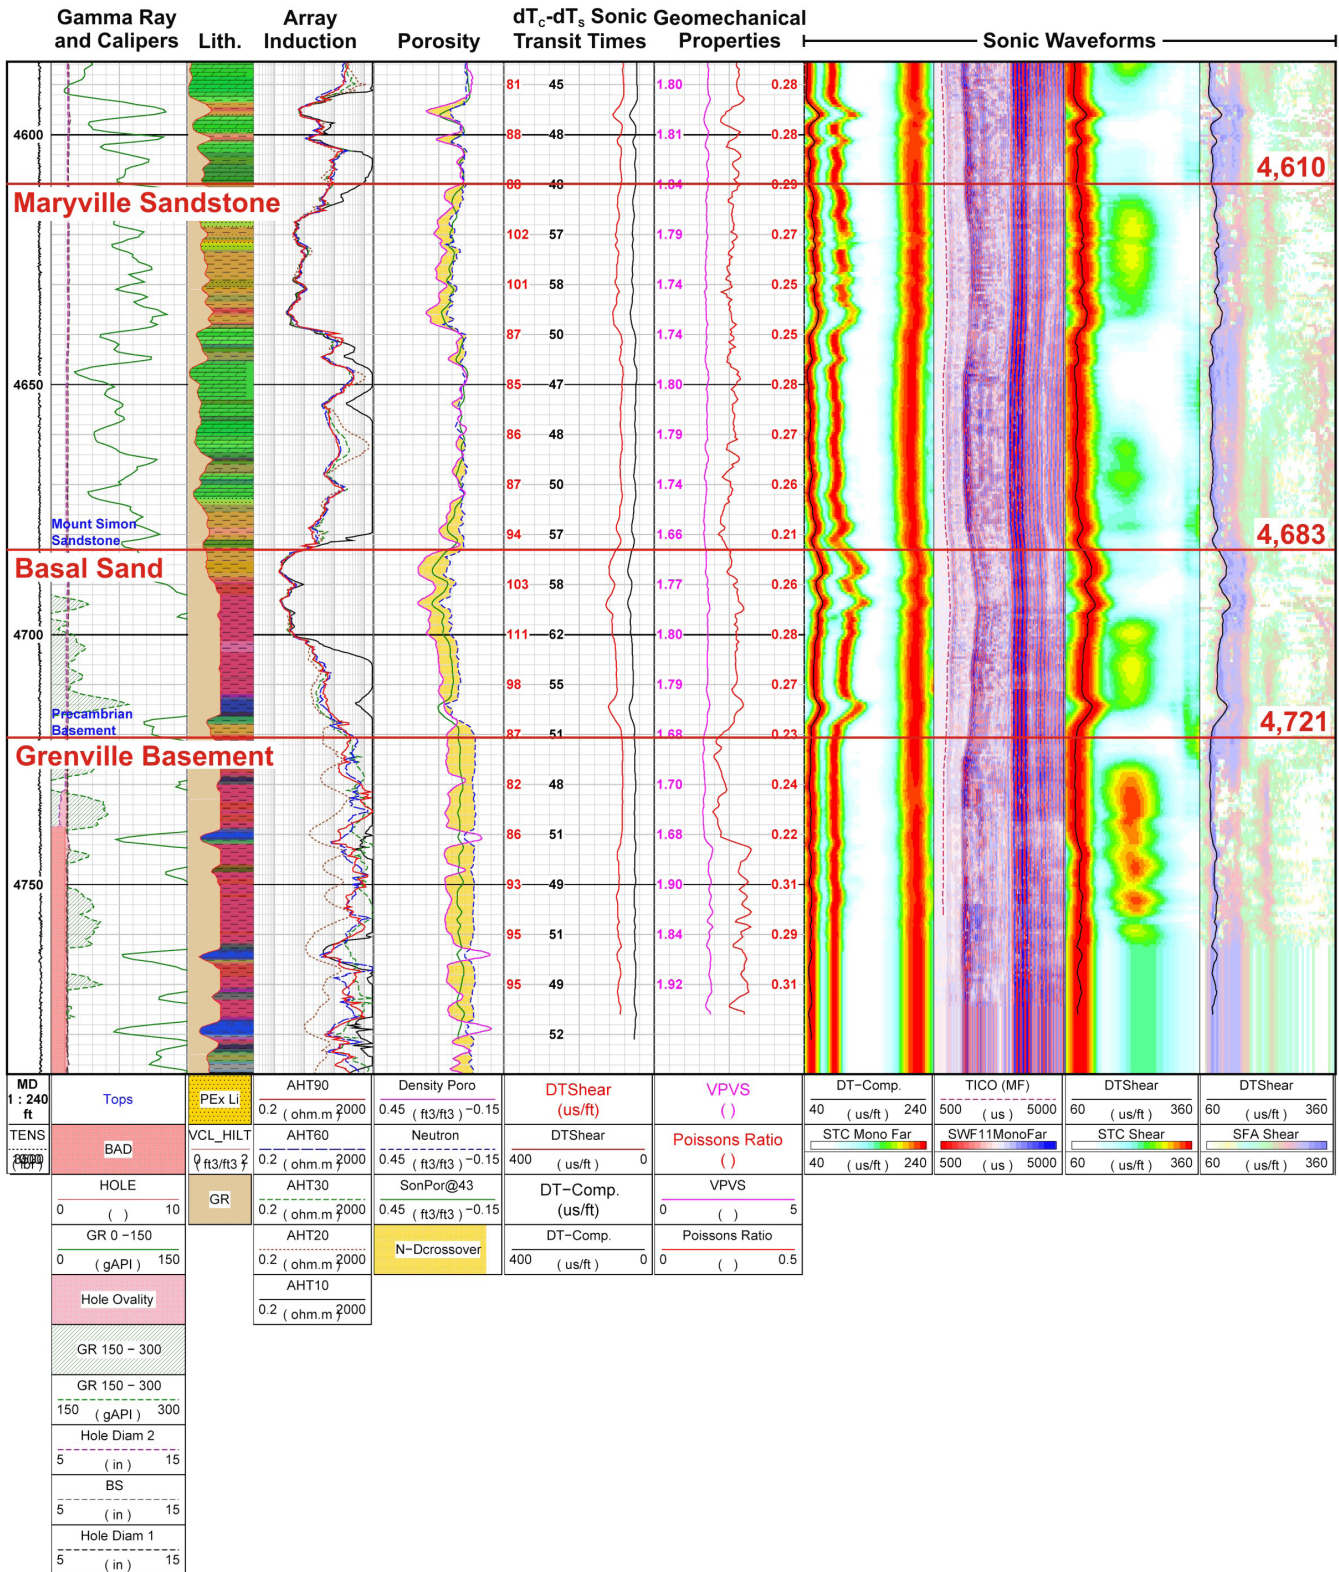
Figure 10. Example of Sonic Scanner analysis (Tamara Oliver, Schlumberger, 2013, personal communication). This log can be used to calculate elastic geomechanical properties of the strata penetrated by the wellbore. Stress-induced anisotropy in a wellbore causes breakouts, identified by the four-arm caliper log and frequency slowness dispersion graphs.

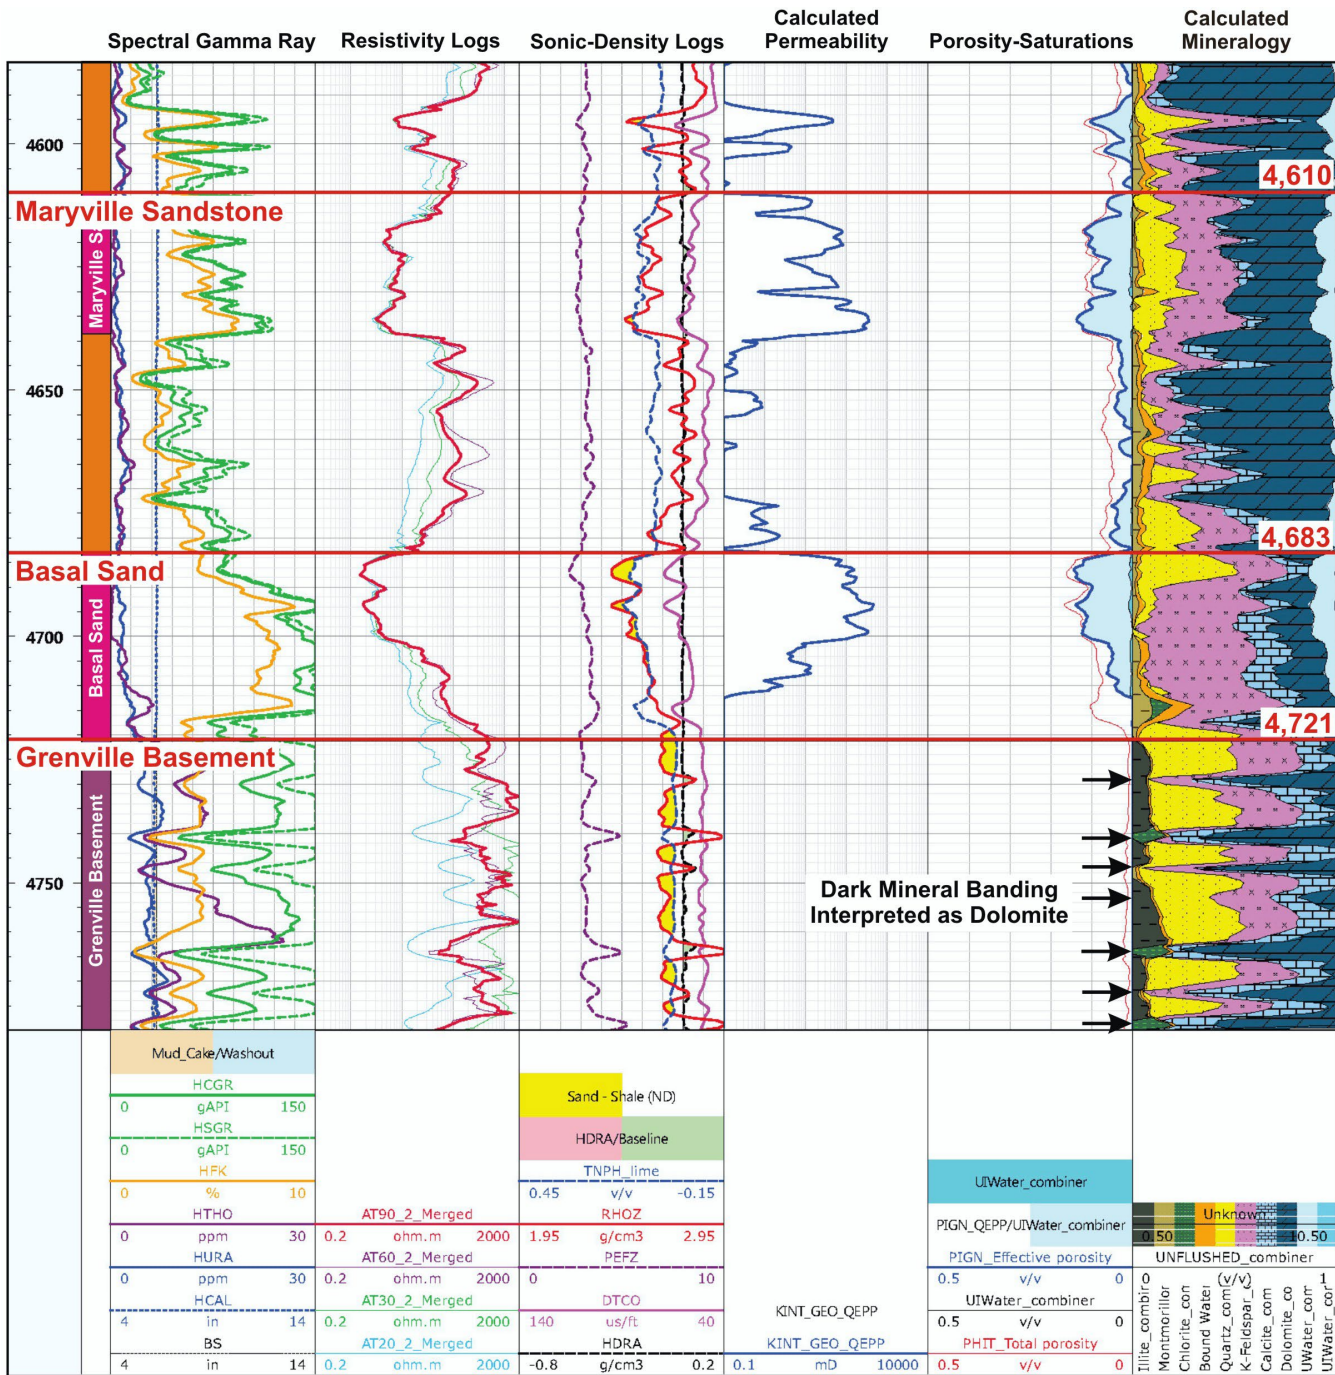
Figure 11. The ELAN log is an analysis of the spectral gamma-ray, array-resistivity, neutron-porosity, and litho-density log suite to create a model of the mineralogical composition, porosity, fluid saturations, and permeability index of strata penetrated by the wellbore (Darling and others, 1991). In this image the high formation density of amphibolite (dark mineral) banding in the Grenville granite gneiss is interpreted by the ELAN analysis as dolomite.
