**Kentucky Geological Survey**  
William C. Haneberg, State Geologist and Director  
University of Kentucky, Lexington

**Overview of the  
Kentucky Geological Survey  
No. 1 Hanson Aggregates Well,  
Carter County, Kentucky**

**J. Richard Bowersox, Stephen F. Greb, and David C. Harris**

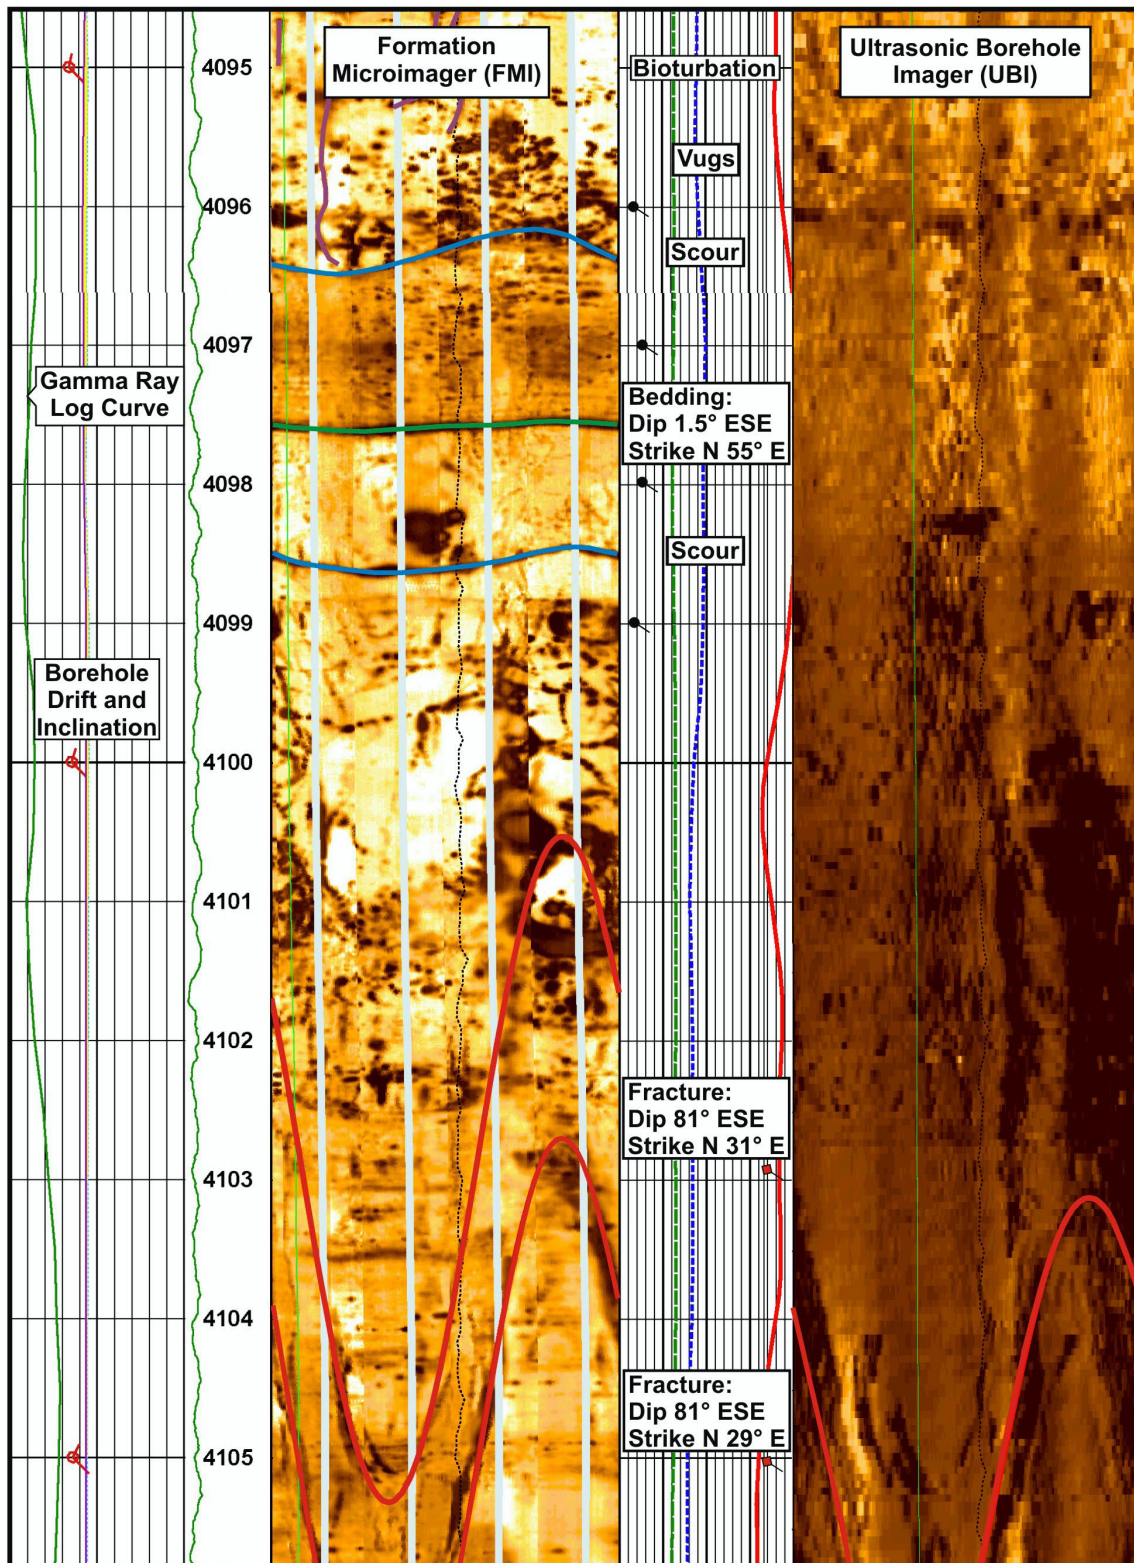
Figure 12. Interpretation of the Formation Microimager and Ultrasonic Borehole Imager image log sections from the Copper Ridge Dolomite, showing vugular porosity (dark spots on the FMI log), bedding, and fractures. The FMI is a microresistivity log and is thus sensitive to the amount of disseminated conductive pyrite in the rock. Pyrite-enriched spots will appear to be vugs. The low-resolution UBI log, from an ultrasonic tool, is not sensitive to pyrite content and will show a more accurate distribution of vugular porosity.

Formation MicroImager and Ultrasonic Borehole Imager logs were run as part of the second log run after the well reached its total depth, and only covered the wellbore below casing at 2,944 ft (Fig. 12, Table 3). The Formation MicroImager log displays a continuous geo-oriented wellbore image computed from microresistivity measurements (Schlumberger, 2002a). This image provides a near-full wellbore view of stratification that can be used to determine sedimentary structures, vugular porosity, bedding, and structural features including fractures and faults (Schlumberger, 2002a) (Fig. 12). The Formation MicroImager image aids log-to-core comparisons, which improve our understanding of the geology of the reservoir and confining strata and make coring the entire wellbore unnecessary (discussed below). Because the image is geo-oriented, bed, fracture, and fault orientations can be interpreted (Fig. 13). As a microresistivity log, however, the FMI response is affected by any conductive minerals in the rock, most notably pyrite. Pyritic intervals will appear to be vugular, although if cored, these intervals may prove to actually be dense limestone and dolomite (Bowersox and Williams, 2014). Thus, additional information is needed to determine and describe vugular intervals in carbonate rocks: commonly from the formation-density, neutron-porosity, and sonic logs. In addition, the Ultrasonic Borehole Imager log can be run independently to provide a visualization of vugular porosity.

ing is independent of the drilling fluid in the wellbore (Schlumberger, 2002b), and, as a sonic log, it is unaffected by conductive minerals in the rock. The UBI log thus supplements the FMI log and can be used to visualize porosity, analyze fractures and the natural stress regime in the borehole, and study borehole stability. The UBI produces a lower-resolution image that loses much of the finer detail displayed in the FMI log through the same wellbore interval, however (Fig. 12). That is, some features visible on the FMI may only be inferred from the UBI log. On the other hand, vugs visible on the FMI log can be confirmed by the UBI log (Fig. 12), thus improving reservoir porosity evaluation.

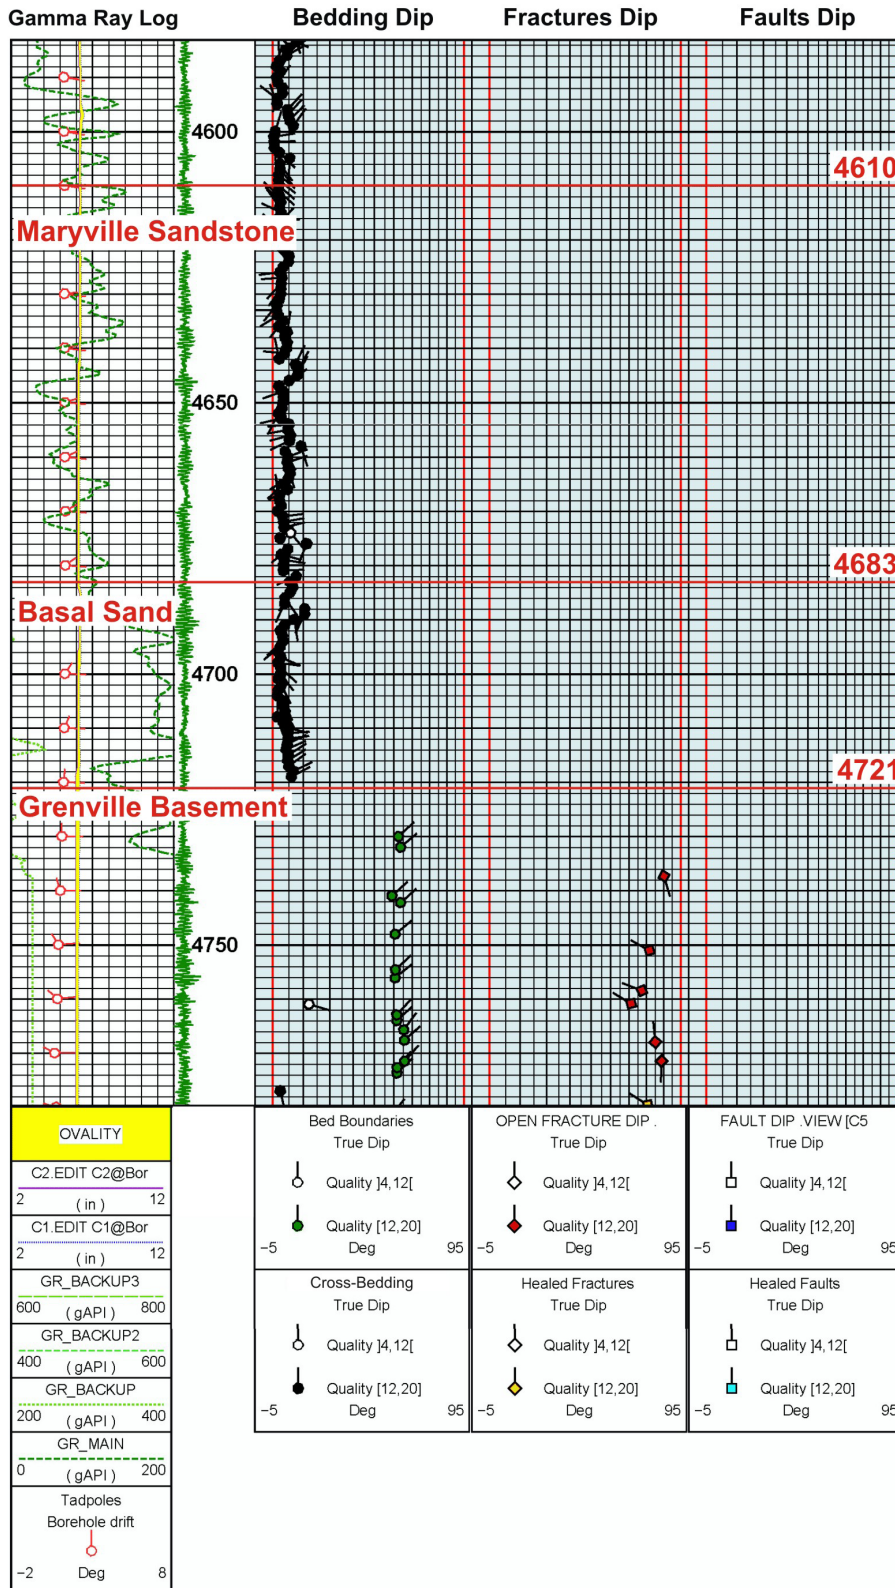
Figure 13. Dipmeter interpretation of bedding and fracturing and faulting features recorded by the Formation MicroImager log. Bedding dip in the Grenville is interpreted from the orientation of the amphibolite bands. Filled colored circles are posted at the depth and dip angle from horizontal of the feature, 0 to 90°(where vertical), and the black lines pointing away from the circles show the compass azimuth of the feature's dip direction (0 at north, then clockwise to 360°).

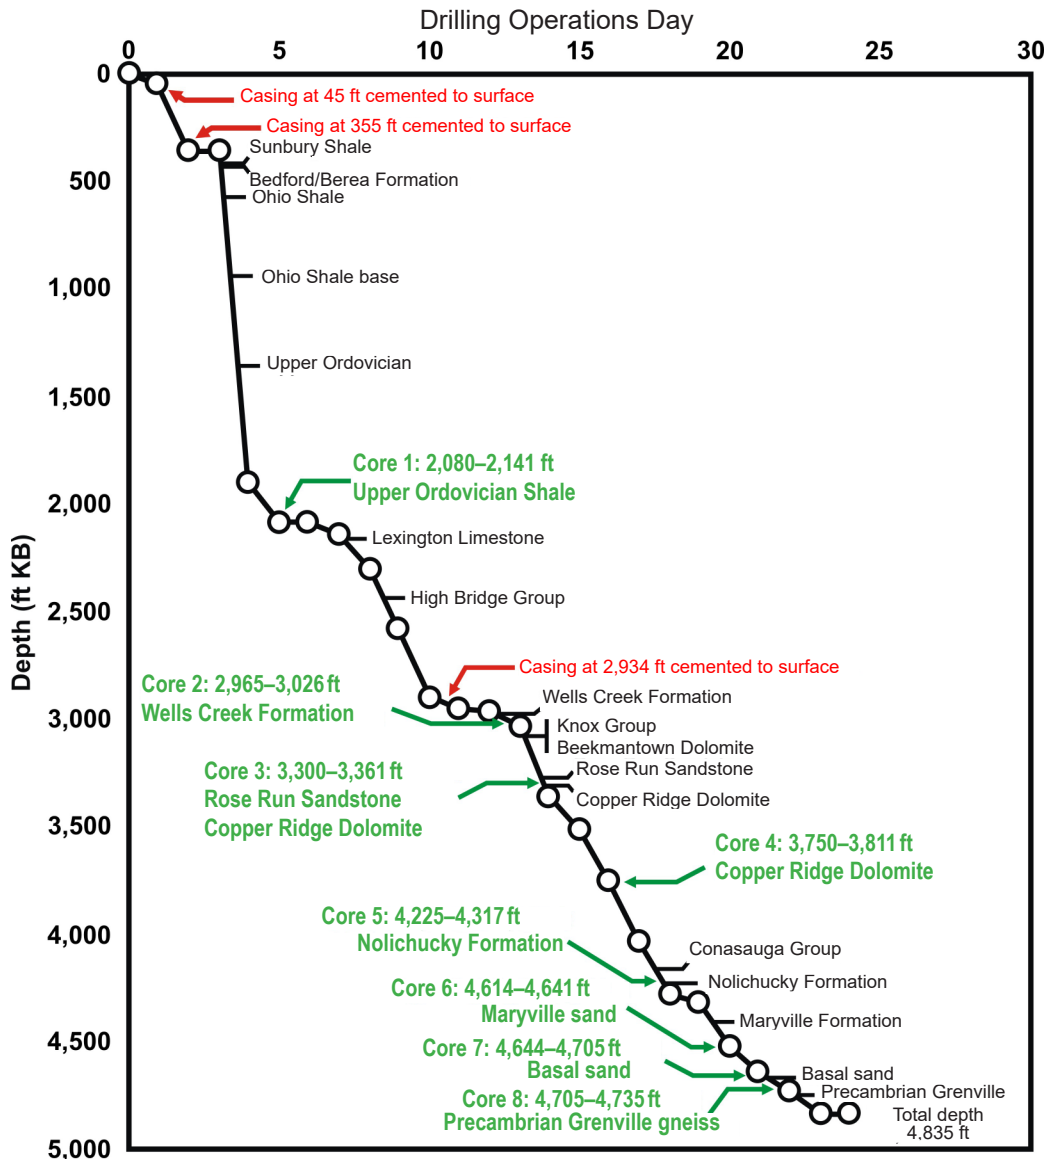
Figure 14. Drilling progress of the No.1 Hanson Aggregates well, annotated with formation tops, core intervals, and casing depths.

ing geophysical well logging, were completed on schedule and within budget in 24 days (Fig. 14).

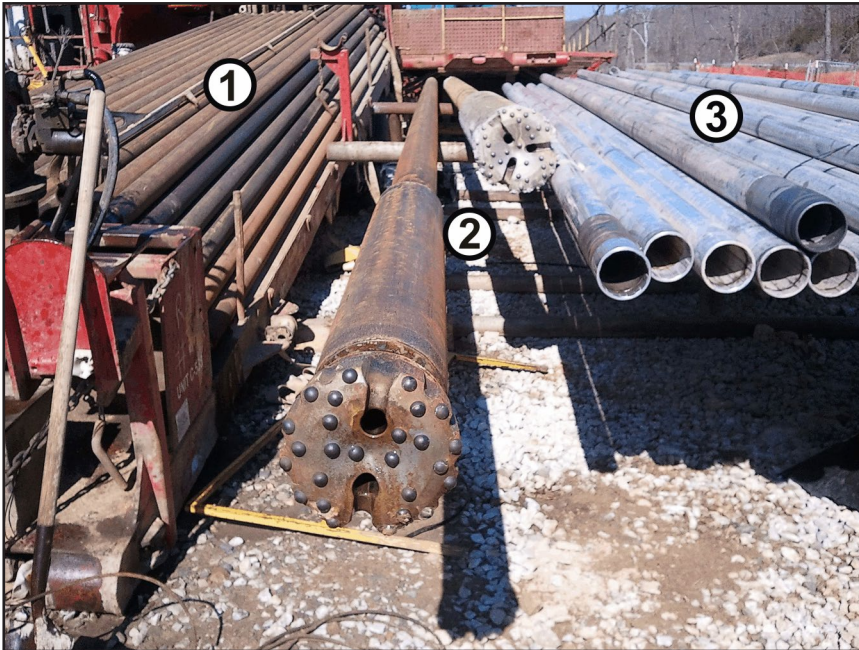
Figure 15. Drilling tools and tubular materials on racks beside the drilling rig, where they were easily accessible to the rig crews during drilling. (1) Drill pipe. (2) Hammer-drill heads. (3) Aluminum core sleeves.

The well was drilled using an air hammer (Fig. 15) to the first core point at 2,080 ft, at which time the wellbore was filled with a 2 percent potassium chloride-based drilling fluid, whose viscosity and water-loss control properties were optimal for coring the Upper Ordovician shale. The purpose of the drilling fluid was to mitigate shale sloughing into the wellbore, which could cause the core barrel to stick. After the first core was recovered, the drilling fluid was displaced from the wellbore and stored in mud pits. Subsequent drilling to 2,944 ft, where 7-in. casing was cemented to the surface, then to 3,520 ft, was by air hammer, after which the influx of formation brine from the Rose Run into the wellbore exceeded the capacity of the air-drilling compression to displace it from the wellbore. Drilling from 3,520 ft to the well's total depth of 4,835 ft used conventional 6¼-in. tricone rotary drill bits and a wellbore fluid system of formation brine and fresh water. Drilling and coring operations, includ-

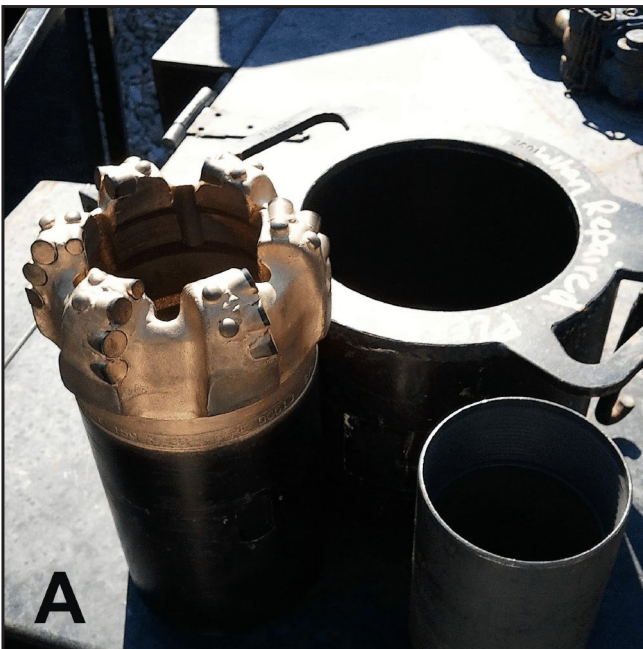
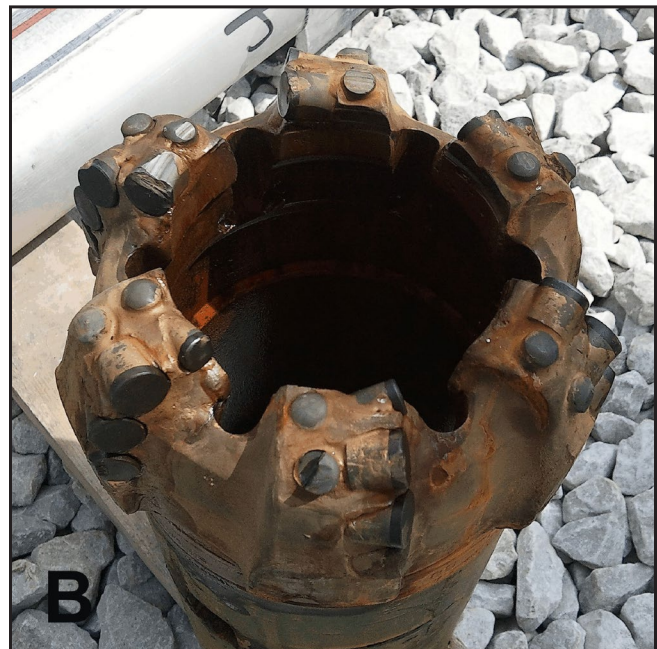
Figure 16. Polycrystalline diamond-cutter core bits used to drill the No. 1 Hanson Aggregates well. (A) A new bit (left), a gage to determine bit wear (center), and core catcher (right) to keep a core inside its aluminum sleeve for recovery. (B) A well-worn core bit after cutting several cores.

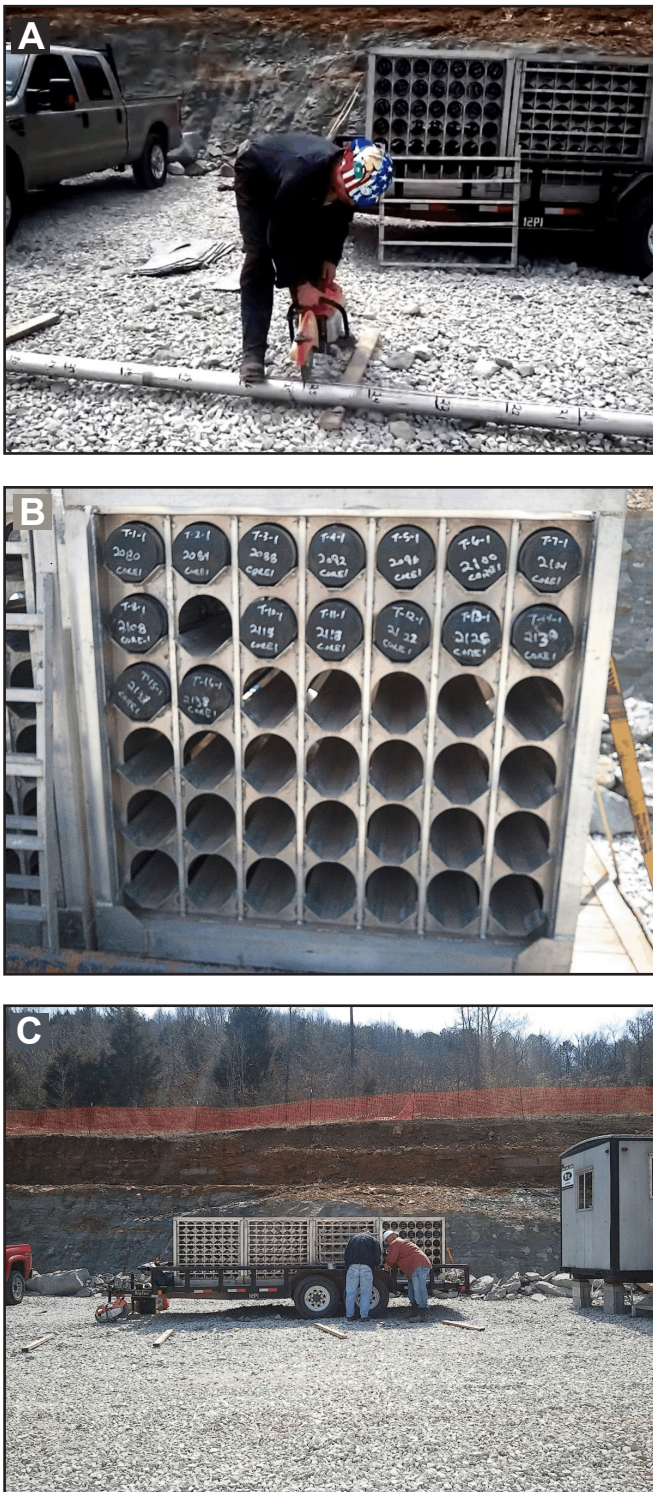
Figure 17. On-site processing of cores. (A) Aluminum core sleeves and cores are cut into sections for shipping, using a diamond-blade concrete saw. (B) Core sections were stored in their capped depth-labeled sleeves in racks for subsequent transport to the lab for analysis. (C) Racks of cores on the trailer to be transported to the lab.

casing cemented at 2,944 ft, had a diameter of 3<sup>1</sup>/<sub>2</sub> in. These were the largest-diameter cores that could be cut in the well, considering the expense of drilling and casing larger-diameter boreholes. To maximize the length of the cored intervals, considering the cost of coring, five cores were approximately 60 ft long, two were 30 ft long, and one was 90 ft long. Cores were cut using polycrystalline diamond-cutter core bits (Figs. 16A, B) and aluminum sleeves with 1/4-in.-thick walls inside the core barrels to ensure core recovery (Figs. 15, 17A). Upon retrieval from the wellbore, cores were cut into 4-ft lengths, the ends of the cut sleeves were capped and sealed, and the cores were stored in transport racks on site until recovery of the last core (Fig. 17B), then transported on a trailer to CoreLab

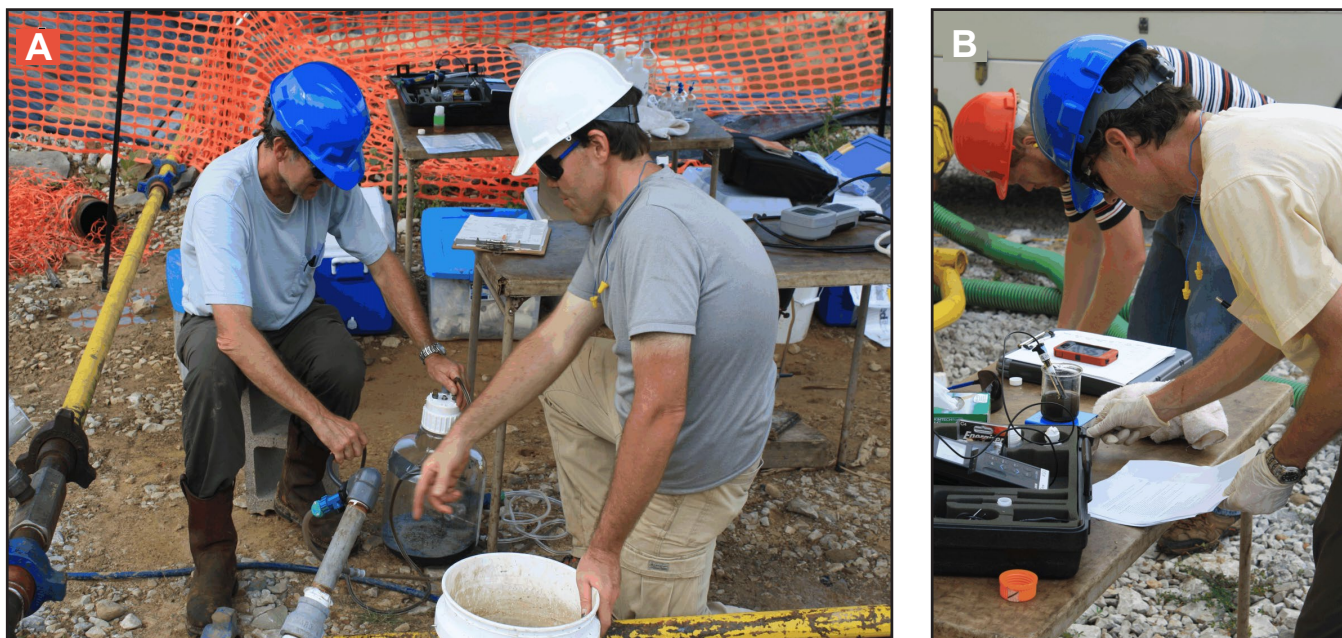
Figure 18. KGS geologists sample formation water swabbed from a step-rate test interval prior to testing. (A) Marty Parris (left) and Steve Webb connect a carboy to collect a water sample. (B) University of Kentucky Department of Earth and Environmental Sciences student Jerry Grider (left) and Marty Parris monitor water-sample conductivity before collecting a sample.

were used to isolate the tops. Prior to each test, we attempted to recover formation water from the isolated test interval (Fig. 18A). Formation water was recovered from the wellbore by swabbing the test interval through the tubing until a stable conductivity was attained (Fig. 18B) for any recovered water. Water samples were collected from the Rose Run Sandstone and Copper Ridge Dolomite, but no fluid could be recovered from the Basal sand-Maryville sand test interval. All three intervals were underpressured, with pressure gradients below 0.465 psi/ft, as would be typical for deep saline reservoirs. Surface-reading pressure-monitoring gages were placed in both the isolated wellbore to monitor for fracturing and in the wellbore annulus above the packer to monitor for fluid leakage during testing. Only drinking water purchased from the Grayson, Ky., municipal water system was used for the step-rate tests.

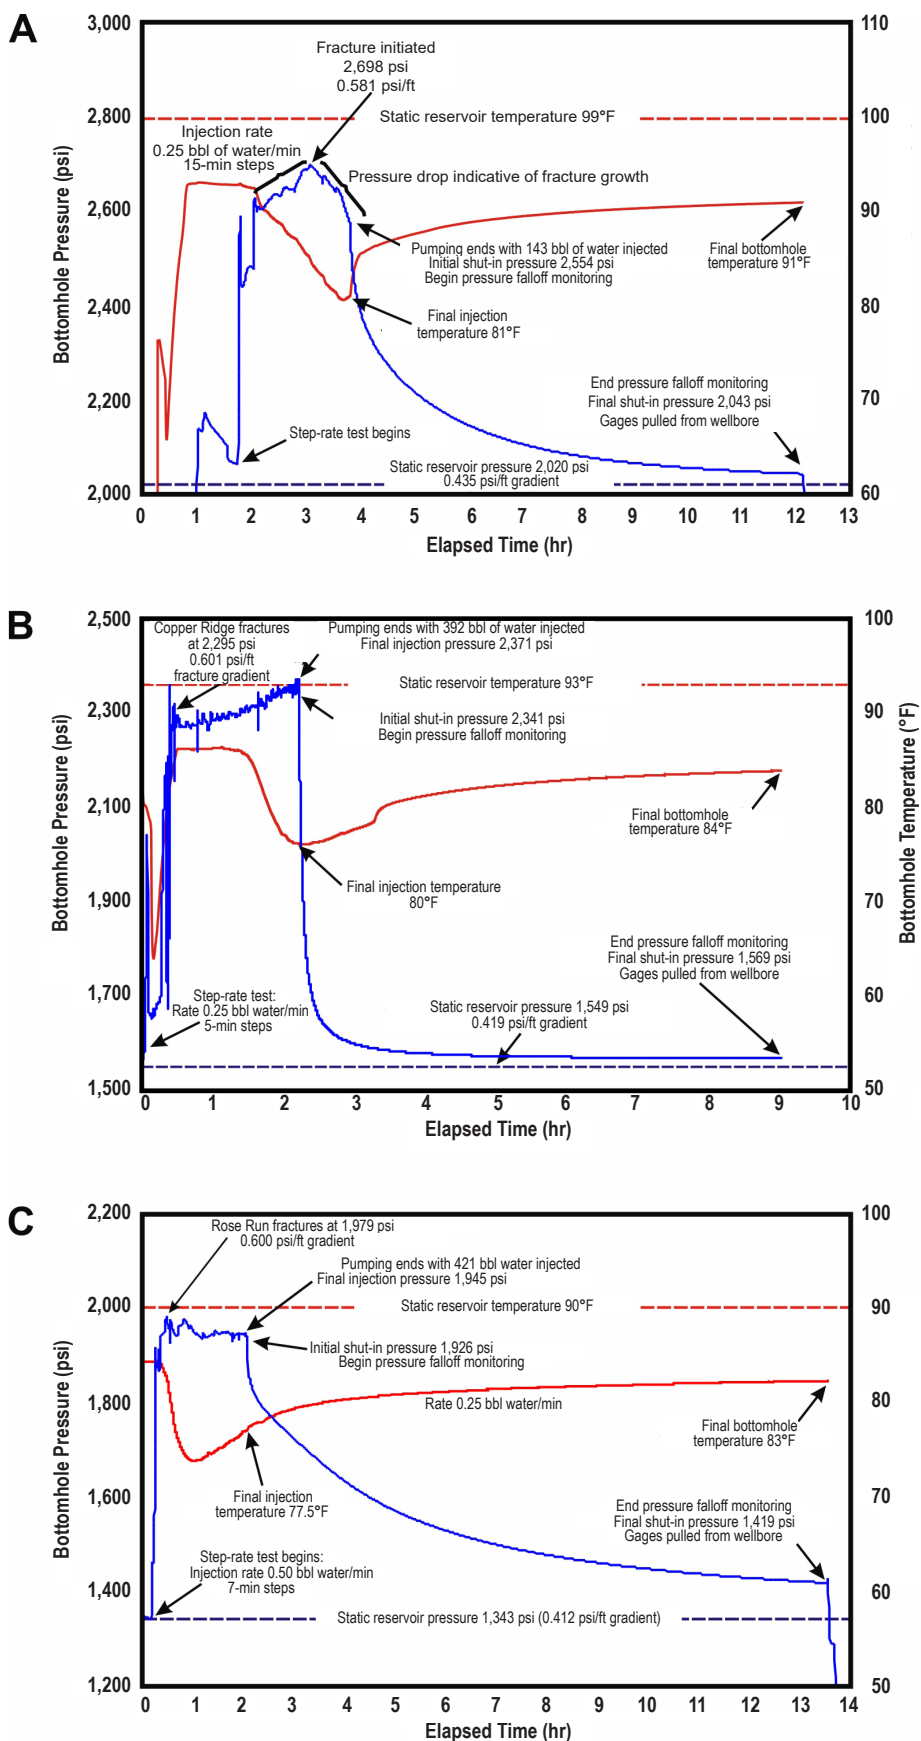
Figure 19. Pressure (blue) and temperature (red) data from the step-rate tests. Injection of water initially cooled the wellbore, but the temperature began to increase because of friction in the test tubing. Only the Maryville-Basal sands fractured; pressure in the Copper Ridge built up during the test, but the unit did not fracture before the water available for testing was nearly depleted and the injection pump was unable to maintain a stable injection rate. Pressure in the Rose Run was stable during injection, varying by less than ±10 psi during the test period, indicating a large reservoir volume with good permeability and porosity. (A) Test 1, Maryville-Basal sands. (B) Test 2, Copper Ridge Dolomite. (C) Test 3, Rose Run Sandstone.

of water/day, and pressure of 2,689 psi, yielding a fracture gradient of 0.58 psi/ft (Fig. 19A), at which time the test was terminated and pressure falloff was monitored for about 12 hr.

steps (Fig. 19B). The test was terminated before the Copper Ridge was fractured because the supply of fresh drinking-water test fluid was exhausted. Pumping pressure did not increase above the 3.5 bbl/min rate (about 5,000 bbl of water/day). After the final step, the well was shut-in and pressure falloff was monitored for about 12 hr.

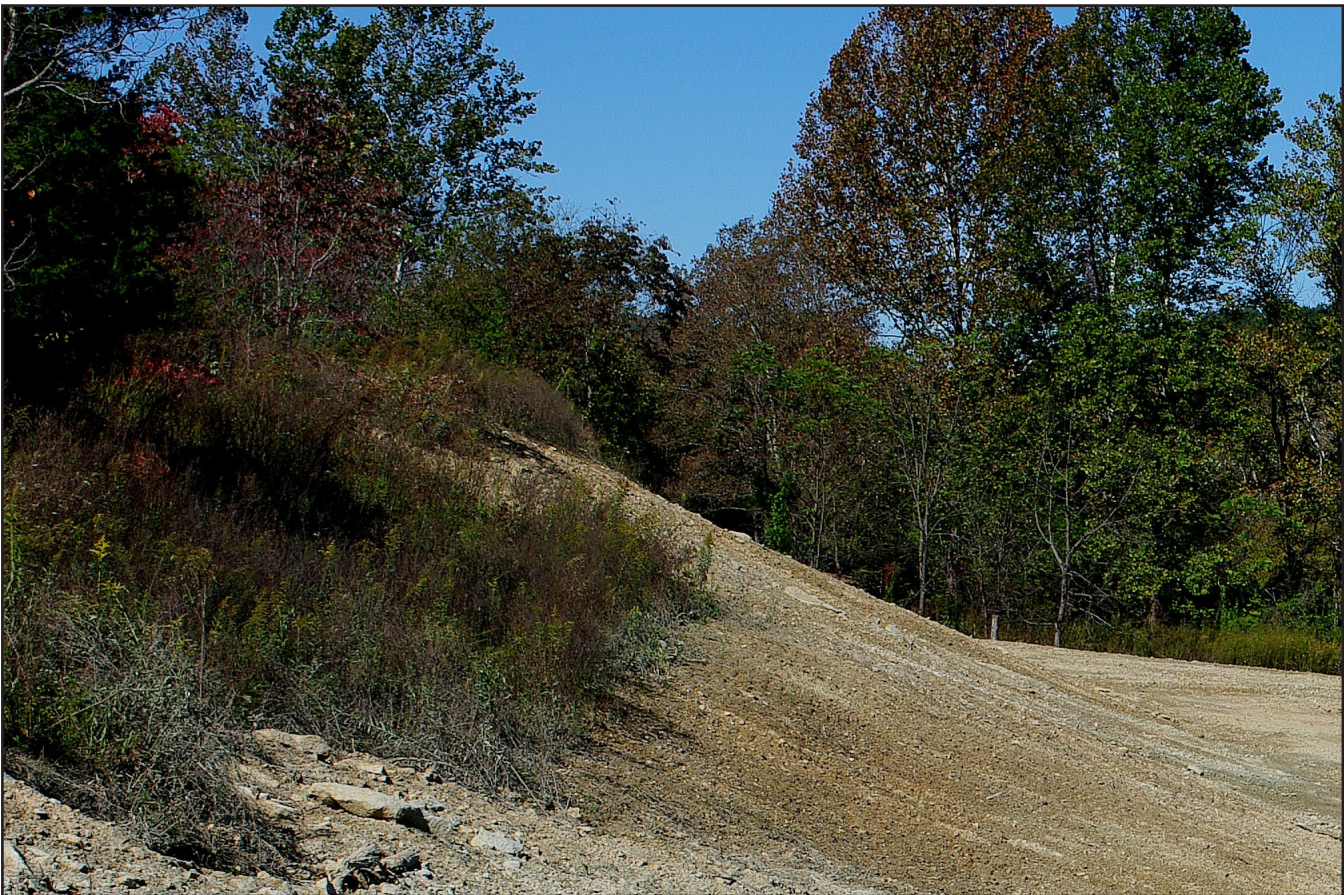
Figure 20. The well site was recontoured during remediation, as required by Hanson Aggregates, and obstructed with large stone blocks to hinder trespassing.
