Generalized Geologic Map for

Land-Use Planning: **Boone County, Kentucky**

Richard A. Smath, Bart Davidson, Daniel I. Carey, and John D. Kiefer

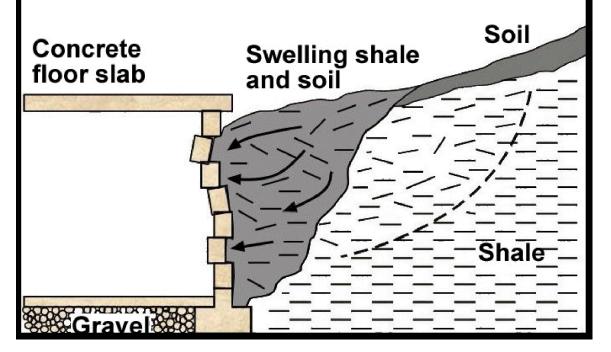
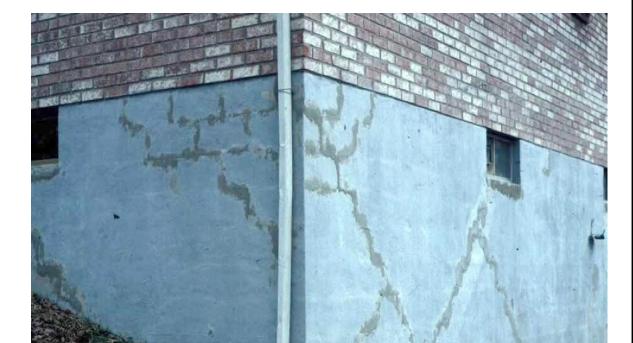
Swelling Shale and Foundation Damage

A problem of considerable concern in this area is the swelling of some of the clay minerals in shale units 2 and 3. Expanding shale can cause backfill to swell, and concrete to crack and crumble. It can heave the foundation, the slab, and interior partitions resting on it, and damage upper floors and interior partitions. This phenomenon has been responsible for extensive damage to schools, homes, and businesses in Kentucky. During times of drought, these same shales may shrink, causing foundations to drop. Anyone planning construction on these shales should seek professional advice from a geologist or engineer familiar with the problem.

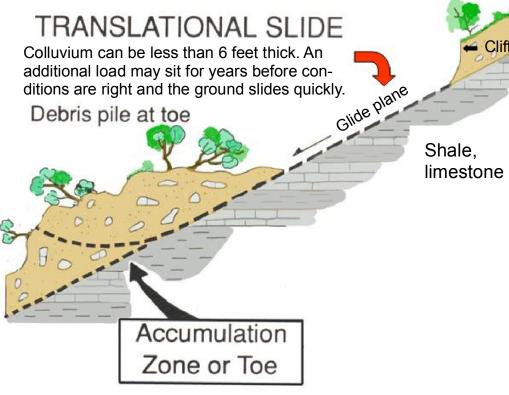
A transitional landslide is a relatively thin sheet of colluvium that separates from the underlying bedrock and slides catastrophically downslope more or less as a coherent sheet until it abruptly stops and becomes a crumbled, disorganized pile of debris. Such failures are common on steeper slopes of shale-dominated units (units 2 and 3) when both colluvium and the weathered, more permeable bedrock below become fully saturated with water. After Potter (1996).

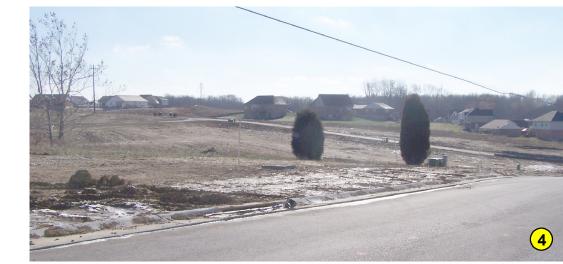
Residential Development

New subdivision under construction on Ky. 338 near Burlington. Northeaster Boone County is being rapidly developed for both residential and industrial use. Photo by Richard Smath, Kentucky Geological Survey.

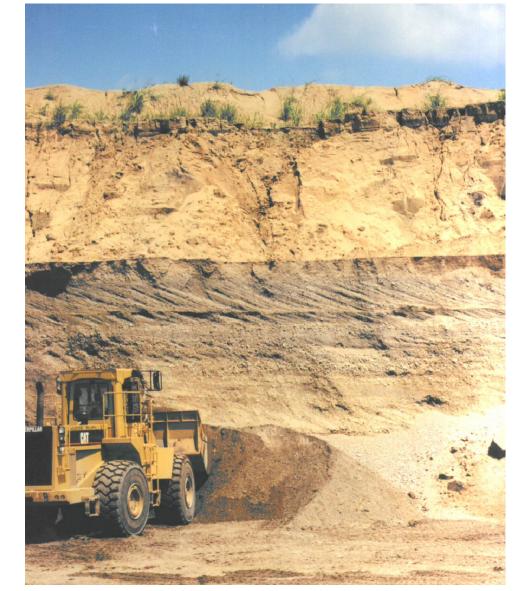
Front-end loader works in the glacial outwash at the Bellevue Sand and Gravel Inc. pit. Photo by Richard Smath, Kentucky Geological Survey.

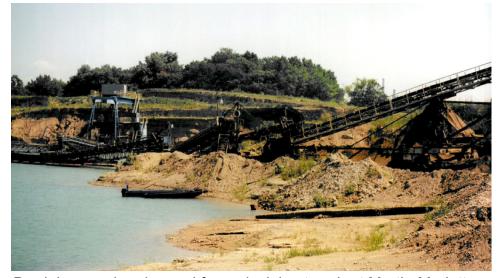
Dredging sand and gravel from glacial outwash at Martin-Marietta Aggregates. Photo by Richard Smath, Kentucky Geological Survey.
